OIL ANALYSIS REPORT

Machine Id
6019
Component
Rear Diesel Engine
Fluid
PETRO CANADA DURON HP 15W40 (18 LTR)

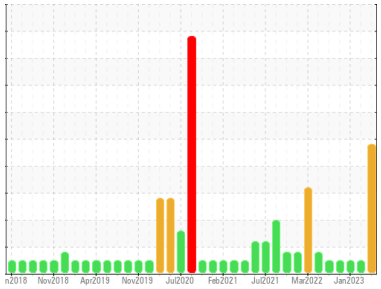
Sample Rating Trend

DIRT

Concentration élevée de saleté dans l`huile.

Nous vous recommandons de vérifier le filtre à air, le système d`induction d`air et tout endroit où la saleté peut entrer dans le composant. Nous avons pris note que l`huile a été vidangée et le filtre remplacé au moment de l`échantillonnage. Nous vous recommandons d`échantillonner de nouveau dès que possible afin de contrôler la situation.

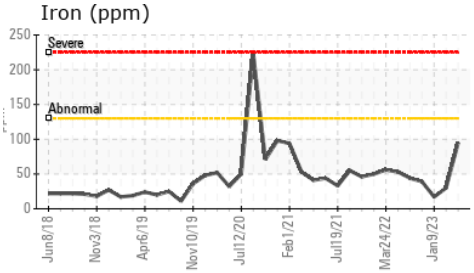
Iron (ppm)

WEAR METALS		method	limit/base	current	history1	history2
Iron	ppm	ASTM D5185(m)	>130	**95**	30	17
Chromium	ppm	ASTM D5185(m)	>10	**6**	<1	<1
Nickel	ppm	ASTM D5185(m)	>4	**<1**	<1	<1
Titanium	ppm	ASTM D5185(m)	>2	**<1**	<1	<1
Silver	ppm	ASTM D5185(m)	>2	**0**	0	0
Aluminum	ppm	ASTM D5185(m)	>20	**10**	7	3
Lead	ppm	ASTM D5185(m)	>20	**1**	0	0
Copper	ppm	ASTM D5185(m)	>125	**50**	<1	<1
Tin	ppm	ASTM D5185(m)	>4	**<1**	0	0
Antimony	ppm	ASTM D5185(m)		**0**	<1	<1
Vanadium	ppm	ASTM D5185(m)		**0**	0	0
Beryllium	ppm	ASTM D5185(m)		**0**	0	0
Cadmium	ppm	ASTM D5185(m)		**0**	0	0

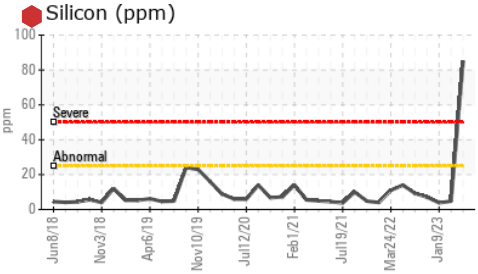
Silicon (ppm)

CONTAMINANTS		method	limit/base	current	history1	history2
Silicon	ppm	ASTM D5185(m)	>25	**85**	5	4
Sodium	ppm	ASTM D5185(m)		**3**	3	2
Potassium	ppm	ASTM D5185(m)	>20	**7**	0	0
Glycol	%	ASTM D7922*		**0.0**	NEG	NEG
