PROBLEM SUMMARY

Machine Id
IMM #15 (S/N 200105)
Component
Hydraulic System
Fluid
PETRO CANADA HYDREX AW 46 (4000 LTR)

OIL ANALYSIS REPORT

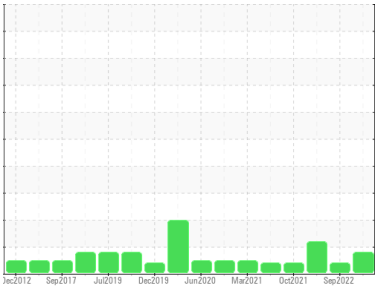
Sample Rating Trend

INSOLUBLES

Sample Status				SEVERE	MARGINAL	ATTENTION
MPC Varnish Potential	Scale	ASTM D7843(m)*	>15	43	17	18
PrtFilter					no image	no image

We advise that you check for visible metal particles in the oil. We recommend that you use electrostatic filtration to remove insolubles from the oil and to reduce the levels of varnish in the system. Alternatively draining a percentage of the oil and topping up with fresh oil (sweetening the oil) may provide a reduction in the varnish potential level. We recommend an early resample to monitor this condition. Please contact your representative for information regarding the proper sampling kits for your service. NOTE: We recommend using Advanced Oil Monitoring (AOM) kits for this system. The AOM test package includes advanced level testing to determine the suitability of turbine and large industrial compressor oils for continued use.

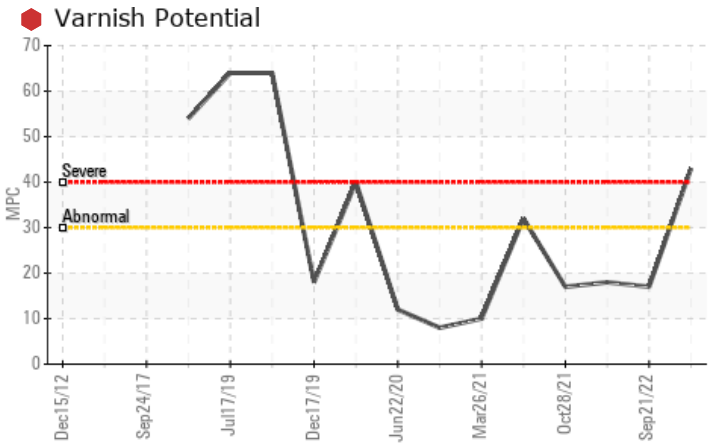
COMPONENT CONDITION SUMMARY

Light concentration of visible metal present.

MPC (Membrane Patch Colorimetry) test indicates a high concentration of varnish present. The system cleanliness is acceptable for your target ISO 4406 cleanliness code.

The AN level is acceptable for this fluid. The condition of the oil is acceptable for the time in service (unconfirmed).

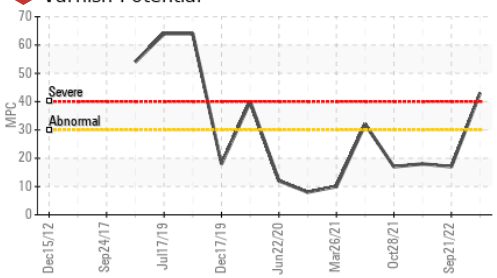
FLUID DEGRADATION		method	limit/base	current	history1	history2
Acid Number (AN)	mg KOH/g	ASTM D974*	0.70	**0.42**	0.30	0.45
MPC Varnish Potential	Scale	ASTM D7843(m)*	>15	**43**	17	18

We advise that you check for visible metal particles in the oil. We recommend that you use electrostatic filtration to remove insolubles from the oil and to reduce the levels of varnish in the system. Alternatively draining a percentage of the oil and topping up with fresh oil (sweetening the oil) may provide a reduction in the varnish potential level. We recommend an early resample to monitor this condition. Please contact your representative for information regarding the proper sampling kits for your service. NOTE: We recommend using Advanced Oil Monitoring (AOM) kits for this system. The AOM test package includes advanced level testing to determine the suitability of turbine and large industrial compressor oils for continued use.

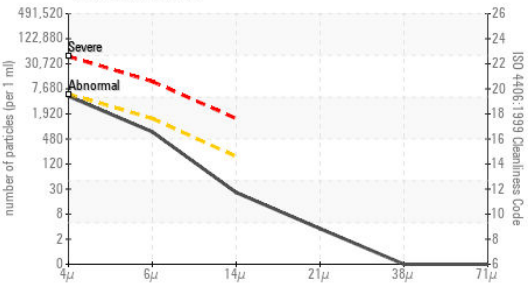
Particle Count

FLUID CLEANLINESS		method	limit/base	current	history1	history2
Particles >4µm		ASTM D7647	>5000	**4454**	1882	▲ 7647
Particles >6µm		ASTM D7647	>1300	**625**	535	1099
Particles >14µm		ASTM D7647	>160	**22**	39	49
Particles >21µm		ASTM D7647	>40	**3**	9	7
Particles >38µm		ASTM D7647	>10	**0**	0	1
Particles >71µm		ASTM D7647	>3	**0**	0	0
Oil Cleanliness		ISO 4406 (c)	>19/17/14	**19/16/12**	18/16/12	▲ 20/17/13
