Machine Id
IMM #16 (S/N 2830058)
Component
Hydraulic System
Fluid
PETRO CANADA HYDREX AW 46 (1500 LTR)

Customer Id: ROPOAK
Sample No.: PC0076918
Lab Number: 02571207
Test Package: IND 2

OIL ANALYSIS REPORT

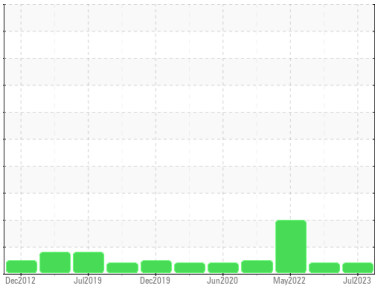
Sample Rating Trend

Sample Status				MARGINAL	MARGINAL	ABNORMAL
MPC Varnish Potential	Scale	ASTM D7843(m)*	>15	▲ 26	▲ 19	▲ 18

We recommend an early resample to monitor this condition. No other corrective action is recommended at this time. Please contact your representative for information regarding the proper sampling kits for your service. NOTE: We recommend using IND 3 test kits, this testkit includes Analytical Ferrography which provides a detailed morphological analysis of wear particles present in the fluid.

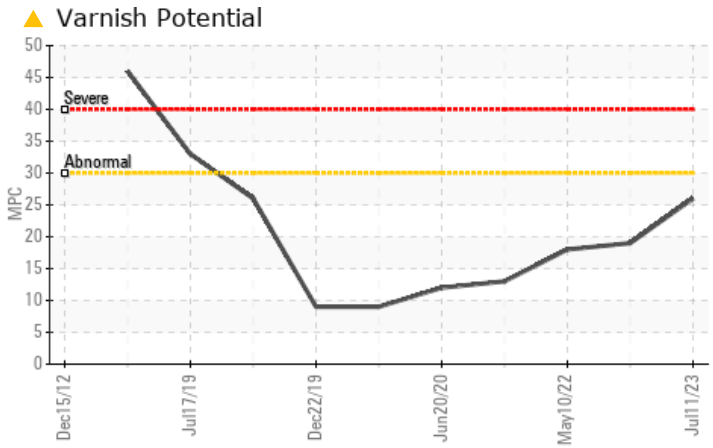
COMPONENT CONDITION SUMMARY

Component wear rates appear to be normal (unconfirmed).

MPC (Membrane Patch Colorimetry) test indicates a light concentration of varnish present.

The AN level is acceptable for this fluid. The condition of the oil is suitable for further service.

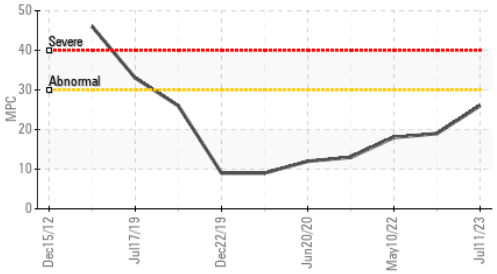
FLUID DEGRADATION		method	limit/base	current	history1	history2
Acid Number (AN)	mg KOH/g	ASTM D974*	0.70	**0.51**	0.32	0.46
MPC Varnish Potential	Scale	ASTM D7843(m)*	>15	▲ **26**	▲ 19	▲ 18

We recommend an early resample to monitor this condition. No other corrective action is recommended at this time. Please contact your representative for information regarding the proper sampling kits for your service. NOTE: We recommend using IND 3 test kits, this testkit includes Analytical Ferrography which provides a detailed morphological analysis of wear particles present in the fluid.

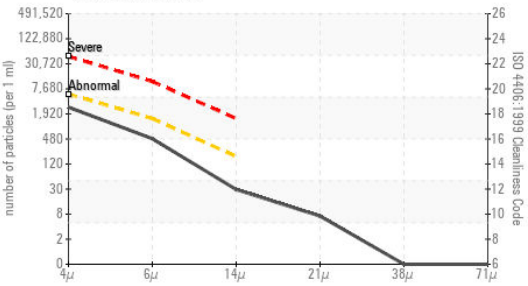
Particle Count

FLUID CLEANLINESS		method	limit/base	current	history1	history2
Particles >4µm		ASTM D7647	>5000	**2440**	3954	▲ 10100
Particles >6µm		ASTM D7647	>1300	**429**	825	▲ 2570
Particles >14µm		ASTM D7647	>160	**26**	31	▲ 213
Particles >21µm		ASTM D7647	>40	**6**	5	36
Particles >38µm		ASTM D7647	>10	**0**	0	4
Particles >71µm		ASTM D7647	>3	**0**	0	0
Oil Cleanliness		ISO 4406 (c)	>19/17/14	**18/16/12**	19/17/12	▲ 21/19/15
