PROBLEM SUMMARY

Machine Id
IMM #5 (S/N 200151)
Component
Hydraulic System
Fluid
PETRO CANADA HYDREX AW 46 (4000 LTR)

Customer Id: ROPOAK
Sample No.: PC0076955
Lab Number: 02571216
Test Package: IND 2

OIL ANALYSIS REPORT

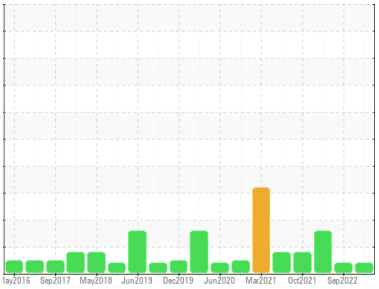
Sample Rating Trend

INSOLUBLES

Sample Status				**MARGINAL**	MARGINAL	ATTENTION
MPC Varnish Potential	Scale	ASTM D7843(m)*	>15	▲ **16**	▲ 16	▲ 15

We recommend an early resample to monitor this condition. No other corrective action is recommended at this time. Please contact your representative for information regarding the proper sampling kits for your service. NOTE: We recommend using Advanced Oil Monitoring (AOM) kits for this system. The AOM test package includes advanced level testing to determine the suitability of turbine and large industrial compressor oils for continued use.

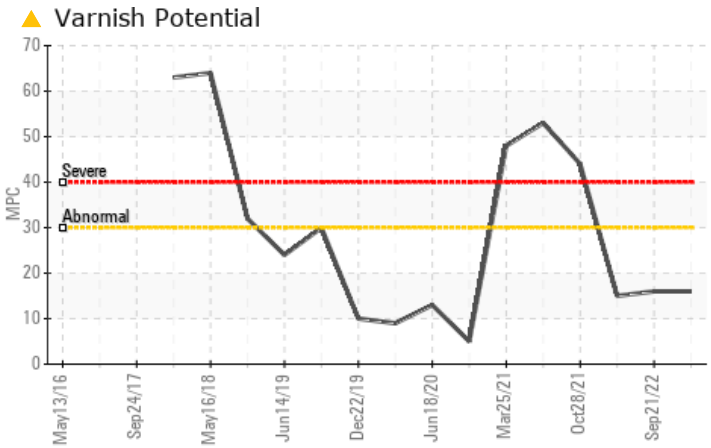
COMPONENT CONDITION SUMMARY

Component wear rates appear to be normal (unconfirmed).

MPC (Membrane Patch Colorimetry) test indicates a light concentration of varnish present.

The AN level is acceptable for this fluid. The condition of the oil is suitable for further service.

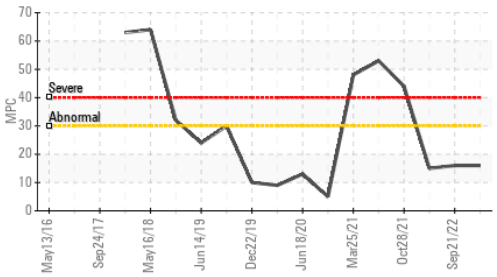
FLUID DEGRADATION		method	limit/base	current	history1	history2
Acid Number (AN)	mg KOH/g	ASTM D974*	0.70	**0.53**	0.31	0.45
MPC Varnish Potential	Scale	ASTM D7843(m)*	>15	▲ **16**	▲ 16	▲ 15

We recommend an early resample to monitor this condition. No other corrective action is recommended at this time. Please contact your representative for information regarding the proper sampling kits for your service. NOTE: We recommend using Advanced Oil Monitoring (AOM) kits for this system. The AOM test package includes advanced level testing to determine the suitability of turbine and large industrial compressor oils for continued use.

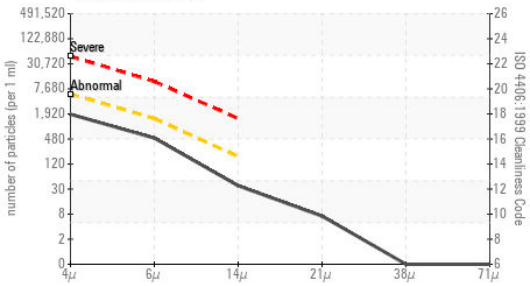
Particle Count

FLUID CLEANLINESS		method	limit/base	current	history1	history2
Particles >4µm		ASTM D7647	>5000	**1647**	1675	▲ 7096
Particles >6µm		ASTM D7647	>1300	**443**	474	▲ 1358
Particles >14µm		ASTM D7647	>160	**32**	26	110
Particles >21µm		ASTM D7647	>40	**6**	4	25
Particles >38µm		ASTM D7647	>10	**0**	0	1
Particles >71µm		ASTM D7647	>3	**0**	0	0
Oil Cleanliness		ISO 4406 (c)	>19/17/14	**18/16/12**	18/16/12	▲ 20/18/14

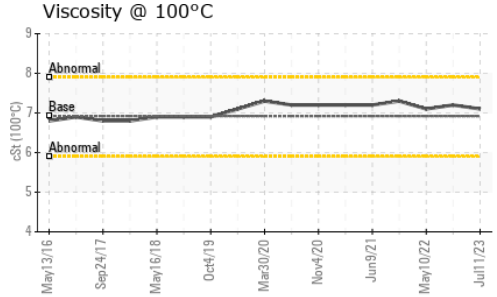
Viscosity @ 100°C

FLUID PROPERTIES		method	limit/base	current	history1	history2
Visc @ 40°C	cSt	ASTM D7279(m)	46.4	**44.8**	45.4	45.2
Visc @ 100°C	cSt	ASTM D7279(m)	6.92	**7.1**	7.2	7.1
Viscosity Index (VI)	Scale	ASTM D2270*	104	**117**	119	116

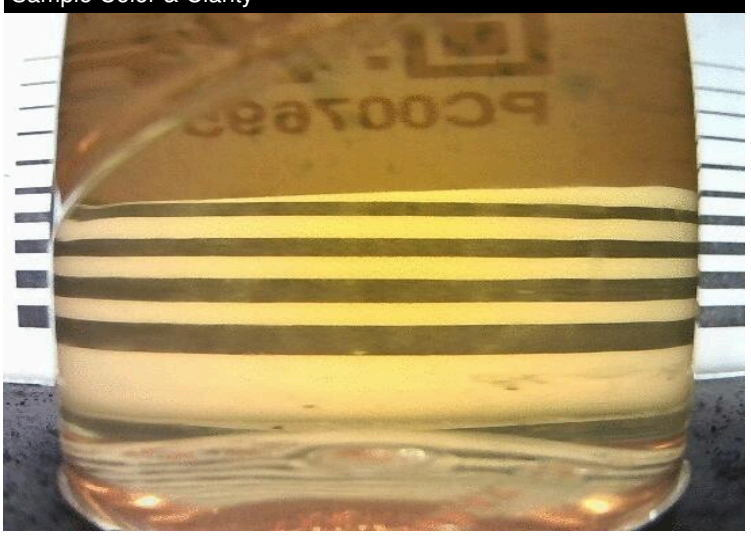
Sample Color & Clarity

VISUAL		method	limit/base	current	history1	history2
White Metal	scalar	Visual*	NONE	**NONE**	NONE	NONE
Yellow Metal	scalar	Visual*	NONE	**NONE**	NONE	NONE
Precipitate	scalar	Visual*	NONE	**NONE**	NONE	NONE
Silt	scalar	Visual*	NONE	**NONE**	NONE	NONE
Debris	scalar	Visual*	NONE	**NONE**	NONE	NONE
Sand/Dirt	scalar	Visual*	NONE	**NONE**	NONE	NONE
Appearance	scalar	Visual*	NORML	**NORML**	NORML	NORML
Odor	scalar	Visual*	NORML	**NORML**	NORML	NORML
Emulsified Water	scalar	Visual*	>0.05	**NEG**	NEG	NEG
Free Water	scalar	Visual*		**NEG**	NEG	NEG
