PROBLEM SUMMARY

Machine Id
IMM #2 (S/N 6259457)
Component
Hydraulic System
Fluid
PETRO CANADA HYDREX AW 46 (3000 LTR)

Customer Id: ROPOAK
Sample No.: PC0076952
Lab Number: 02571221
Test Package: IND 2

OIL ANALYSIS REPORT

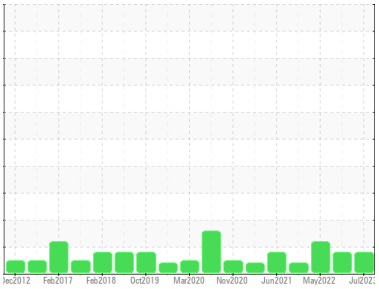
Sample Rating Trend

INSOLUBLES

Sample Status				SEVERE	SEVERE	ATTENTION
MPC Varnish Potential	Scale	ASTM D7843(m)*	>15	62	42	26

We recommend that you use electrostatic filtration to remove insolubles from the oil and to reduce the levels of varnish in the system. Alternatively draining a percentage of the oil and topping up with fresh oil (sweetening the oil) may provide a reduction in the varnish potential level. We recommend an early resample to monitor this condition. Please contact your representative for information regarding the proper sampling kits for your service. NOTE: We recommend using IND 3 test kits, this testkit includes Analytical Ferrography which provides a detailed morphological analysis of wear particles present in the fluid.

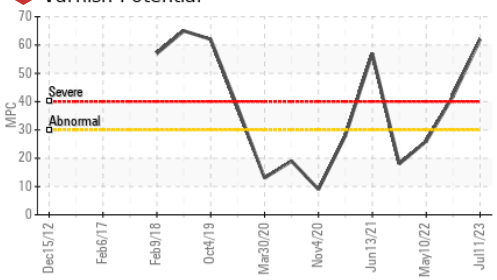
Varnish Potential

MPC (Membrane Patch Colorimetry) test indicates a high concentration of varnish present. The system cleanliness is acceptable for your target ISO 4406 cleanliness code.

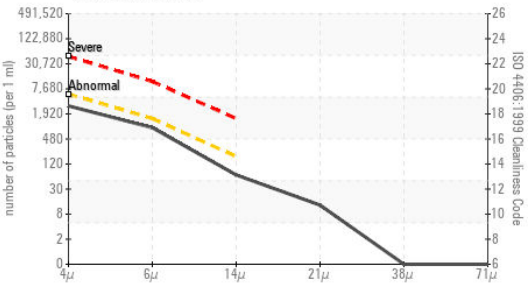
Particle Count

FLUID CLEANLINESS		method	limit/base	current	history1	history2
Particles >4µm		ASTM D7647	>5000	**2616**	1412	4762
Particles >6µm		ASTM D7647	>1300	**785**	332	▲ 1415
Particles >14µm		ASTM D7647	>160	**58**	16	138
Particles >21µm		ASTM D7647	>40	**11**	2	28
Particles >38µm		ASTM D7647	>10	**0**	0	2
Particles >71µm		ASTM D7647	>3	**0**	0	0
Oil Cleanliness		ISO 4406 (c)	>19/17/14	**19/17/13**	18/16/11	▲ 19/18/14

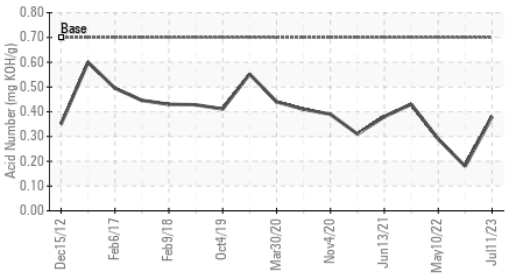
Acid Number

The AN level is acceptable for this fluid.
