Machine Id
IMM #26 (S/N 5142159)
Component
Hydraulic System
Fluid
PETRO CANADA HYDREX AW 46 (1500 LTR)

Customer Id: ROPOAK
Sample No.: PC0076975
Lab Number: 02571235
Test Package: IND 2

OIL ANALYSIS REPORT

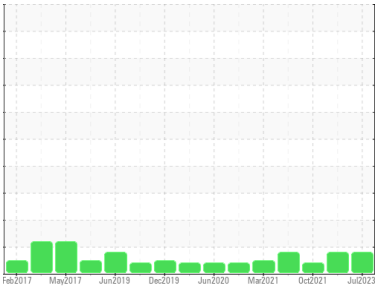
Sample Rating Trend

INSOLUBLES

Sample Status				**SEVERE**	SEVERE	MARGINAL
MPC Varnish Potential	Scale	ASTM D7843(m)*	>15	**62**	56	23

We recommend that you use electrostatic filtration to remove insolubles from the oil and to reduce the levels of varnish in the system. Alternatively draining a percentage of the oil and topping up with fresh oil (sweetening the oil) may provide a reduction in the varnish potential level. We recommend an early resample to monitor this condition. Please contact your representative for information regarding the proper sampling kits for your service. NOTE: We recommend using IND 3 test kits, this testkit includes Analytical Ferrography which provides a detailed morphological analysis of wear particles present in the fluid.

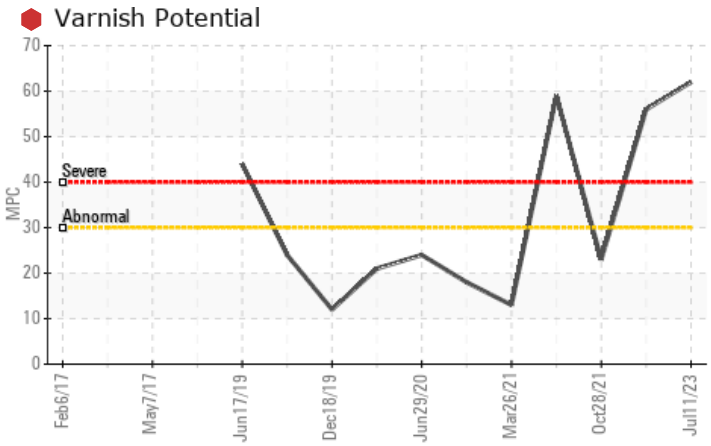
COMPONENT CONDITION SUMMARY

MPC (Membrane Patch Colorimetry) test indicates a high concentration of varnish present. The system cleanliness is acceptable for your target ISO 4406 cleanliness code.

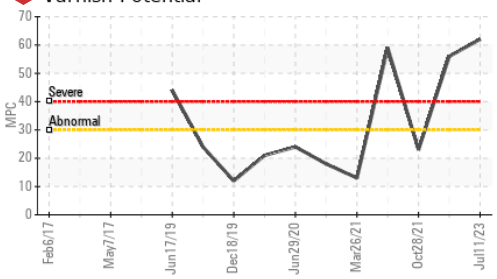
FLUID DEGRADATION		method	limit/base	current	history1	history2
Acid Number (AN)	mg KOH/g	ASTM D974*	0.70	**0.44**	0.29	0.39
MPC Varnish Potential	Scale	ASTM D7843(m)*	>15	**62**	56	23

We recommend that you use electrostatic filtration to remove insolubles from the oil and to reduce the levels of varnish in the system. Alternatively draining a percentage of the oil and topping up with fresh oil (sweetening the oil) may provide a reduction in the varnish potential level. We recommend an early resample to monitor this condition. Please contact your representative for information regarding the proper sampling kits for your service. NOTE: We recommend using IND 3 test kits, this testkit includes Analytical Ferrography which provides a detailed morphological analysis of wear particles present in the fluid.

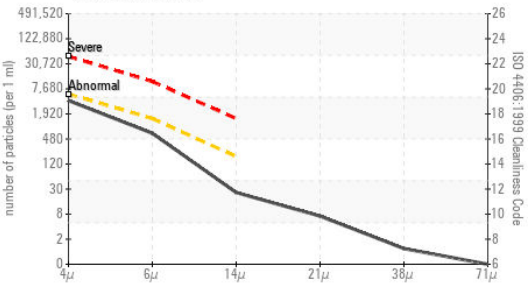
Particle Count

FLUID CLEANLINESS		method	limit/base	current	history1	history2
Particles >4µm		ASTM D7647	>5000	**3509**	1919	231
Particles >6µm		ASTM D7647	>1300	**577**	475	51
Particles >14µm		ASTM D7647	>160	**22**	26	8
Particles >21µm		ASTM D7647	>40	**6**	6	2
Particles >38µm		ASTM D7647	>10	**1**	1	0
Particles >71µm		ASTM D7647	>3	**0**	0	0
Oil Cleanliness		ISO 4406 (c)	>19/17/14	**19/16/12**	18/16/12	15/13/10

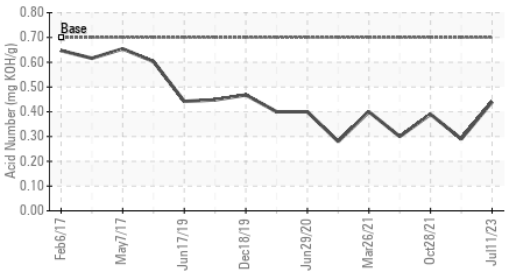
Acid Number

The AN level is acceptable for this fluid.
