PROBLEM SUMMARY

Machine Id
IMM #25 (S/N 5142163)
Component
Hydraulic System
Fluid
PETRO CANADA HYDREX AW 46 (1500 LTR)

Customer Id: ROPOAK
Sample No.: PC0076977
Lab Number: 02571236
Test Package: IND 2

OIL ANALYSIS REPORT

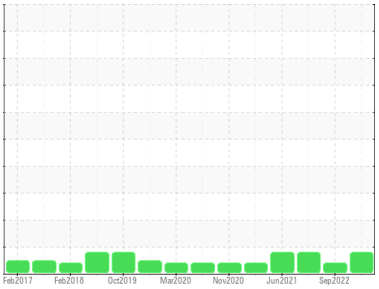
Sample Rating Trend

INSOLUBLES

Sample Status				SEVERE	ABNORMAL	SEVERE
MPC Varnish Potential	Scale	ASTM D7843(m)*	>15	52	32	53

We recommend that you use electrostatic filtration to remove insolubles from the oil and to reduce the levels of varnish in the system. Alternatively draining a percentage of the oil and topping up with fresh oil (sweetening the oil) may provide a reduction in the varnish potential level. We recommend an early resample to monitor this condition. Please contact your representative for information regarding the proper sampling kits for your service. NOTE: We recommend using IND 3 test kits, this testkit includes Analytical Ferrography which provides a detailed morphological analysis of wear particles present in the fluid.

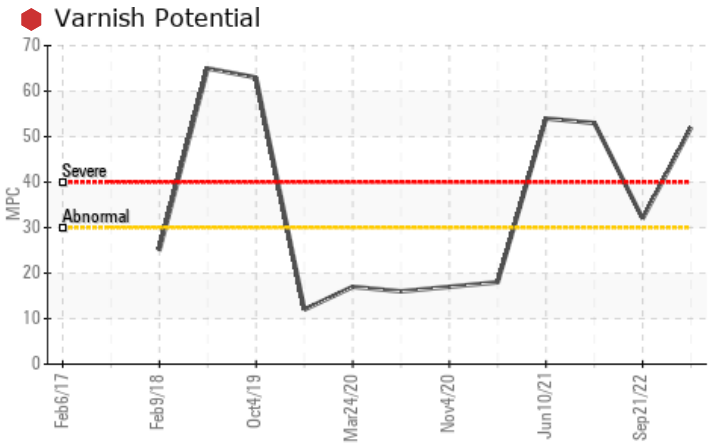
COMPONENT CONDITION SUMMARY

MPC (Membrane Patch Colorimetry) test indicates a high concentration of varnish present. The system cleanliness is acceptable for your target ISO 4406 cleanliness code.

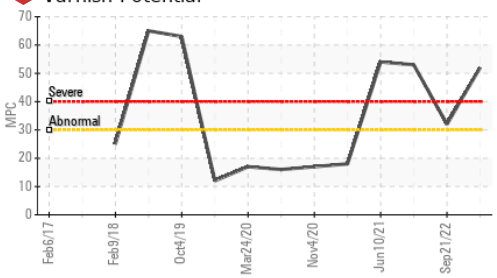
FLUID DEGRADATION		method	limit/base	current	history1	history2
Acid Number (AN)	mg KOH/g	ASTM D974*	0.70	**0.40**	0.27	0.40
MPC Varnish Potential	Scale	ASTM D7843(m)*	>15	**52**	32	53

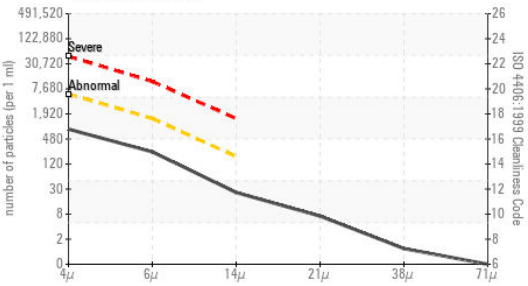
Particle Count

FLUID CLEANLINESS		method	limit/base	current	history1	history2
Particles >4µm		ASTM D7647	>5000	**726**	2711	483
Particles >6µm		ASTM D7647	>1300	**207**	632	142
Particles >14µm		ASTM D7647	>160	**22**	34	11
Particles >21µm		ASTM D7647	>40	**6**	10	3
Particles >38µm		ASTM D7647	>10	**1**	0	0
Particles >71µm		ASTM D7647	>3	**0**	0	0
Oil Cleanliness		ISO 4406 (c)	>19/17/14	**17/15/12**	19/16/12	16/14/11

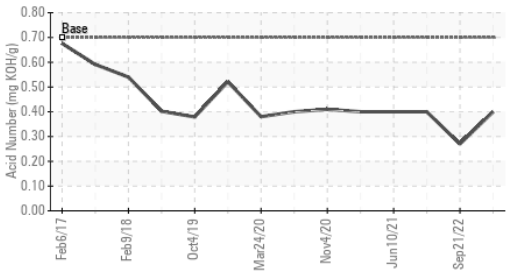
Acid Number

The AN level is acceptable for this fluid.
