Customer Id: ROPOAK
Sample No.: PC0076959
Lab Number: 02571238
Test Package: IND 2

OIL ANALYSIS REPORT

Machine Id
IMM #9 (S/N 61022222)
Component
Hydraulic System
Fluid
PETRO CANADA HYDREX AW 46 (2000 LTR)

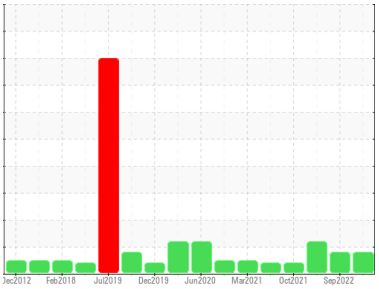
Sample Rating Trend

INSOLUBLES

Sample Status				SEVERE	SEVERE	ATTENTION
MPC Varnish Potential	Scale	ASTM D7843(m)*	>15	**52**	47	12

We recommend that you use electrostatic filtration to remove insolubles from the oil and to reduce the levels of varnish in the system. Alternatively draining a percentage of the oil and topping up with fresh oil (sweetening the oil) may provide a reduction in the varnish potential level. We recommend an early resample to monitor this condition. Please contact your representative for information regarding the proper sampling kits for your service. NOTE: We recommend using IND 3 test kits, this testkit includes Analytical Ferrography which provides a detailed morphological analysis of wear particles present in the fluid.

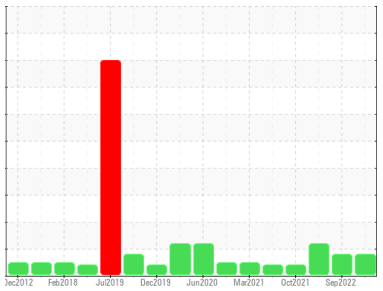
Sample Rating Trend

INSOLUBLES

MPC (Membrane Patch Colorimetry) test indicates a high concentration of varnish present. The system cleanliness is acceptable for your target ISO 4406 cleanliness code.

We recommend that you use electrostatic filtration to remove insolubles from the oil and to reduce the levels of varnish in the system. Alternatively draining a percentage of the oil and topping up with fresh oil (sweetening the oil) may provide a reduction in the varnish potential level. We recommend an early resample to monitor this condition. Please contact your representative for information regarding the proper sampling kits for your service. NOTE: We recommend using IND 3 test kits, this testkit includes Analytical Ferrography which provides a detailed morphological analysis of wear particles present in the fluid.

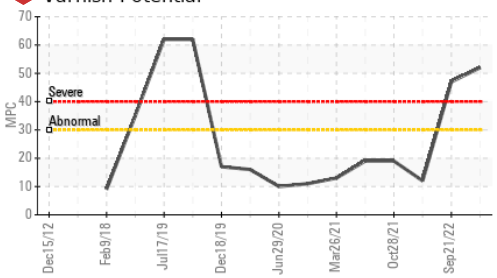
FLUID DEGRADATION		method	limit/base	current	history1	history2
Acid Number (AN)	mg KOH/g	ASTM D974*	0.70	**0.37**	0.29	0.35
MPC Varnish Potential	Scale	ASTM D7843(m)*	>15	**52**	47	12

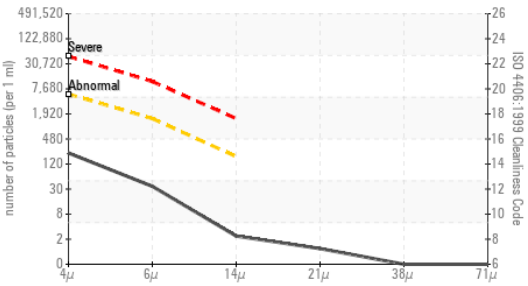
Particle Count

FLUID CLEANLINESS		method	limit/base	current	history1	history2
Particles >4µm		ASTM D7647	>5000	**195**	1866	▲ 6823
Particles >6µm		ASTM D7647	>1300	**31**	412	▲ 1568
Particles >14µm		ASTM D7647	>160	**2**	30	91
Particles >21µm		ASTM D7647	>40	**1**	8	13
Particles >38µm		ASTM D7647	>10	**0**	0	1
Particles >71µm		ASTM D7647	>3	**0**	0	0
Oil Cleanliness		ISO 4406 (c)	>19/17/14	**15/12/9**	18/16/12	▲ 20/18/14

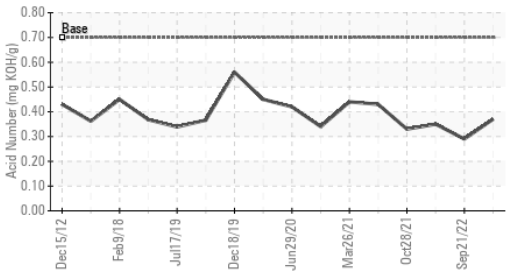
Acid Number

The AN level is acceptable for this fluid.
