Customer Id: ROPOAK
Sample No.: PC0076962
Lab Number: 02571240
Test Package: IND 2

OIL ANALYSIS REPORT

Machine Id
IMM #12 (S/N 2018171)
Component
Hydraulic System
Fluid
PETRO CANADA HYDREX AW 46 (4000 LTR)

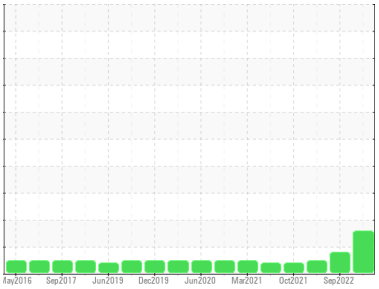
Sample Rating Trend

INSOLUBLES

Sample Status				ABNORMAL	SEVERE	NORMAL
Particles >4µm		ASTM D7647	>5000	▲ **11193**	1986	3180
Particles >6µm		ASTM D7647	>1300	▲ **2068**	577	889
Oil Cleanliness		ISO 4406 (c)	>19/17/14	▲ **21/18/10**	18/16/13	19/17/13
MPC Varnish Potential	Scale	ASTM D7843(m)*	>15	▲ **19**	⬢ 43	9

We recommend you service the filters on this component. We recommend an early resample to monitor this condition. No other corrective action is recommended at this time. Please contact your representative for information regarding the proper sampling kits for your service. NOTE: We recommend using Advanced Oil Monitoring (AOM) kits for this system. The AOM test package includes advanced level testing to determine the suitability of turbine and large industrial compressor oils for continued use.

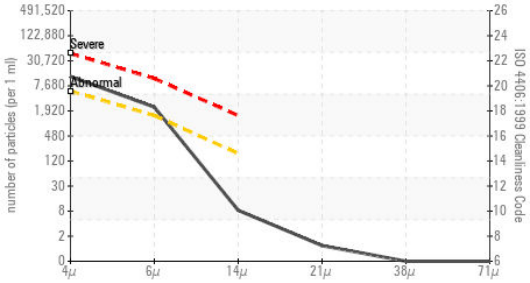
Particle Count

There is a moderate amount of silt (particulates < 14 microns in size) present in the oil. MPC (Membrane Patch Colorimetry) test indicates a light concentration of varnish present.

FLUID CLEANLINESS		method	limit/base	current	history1	history2
Particles >4µm		ASTM D7647	>5000	▲ **11193**	1986	3180
Particles >6µm		ASTM D7647	>1300	▲ **2068**	577	889
Particles >14µm		ASTM D7647	>160	**7**	44	79
Particles >21µm		ASTM D7647	>40	**1**	11	19
Particles >38µm		ASTM D7647	>10	**0**	0	0
Particles >71µm		ASTM D7647	>3	**0**	0	0
Oil Cleanliness		ISO 4406 (c)	>19/17/14	▲ **21/18/10**	18/16/13	19/17/13

We recommend you service the filters on this component. We recommend an early resample to monitor this condition. No other corrective action is recommended at this time. Please contact your representative for information regarding the proper sampling kits for your service. NOTE: We recommend using Advanced Oil Monitoring (AOM) kits for this system. The AOM test package includes advanced level testing to determine the suitability of turbine and large industrial compressor oils for continued use.

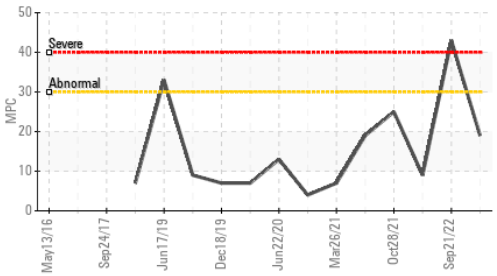
FLUID DEGRADATION		method	limit/base	current	history1	history2
Acid Number (AN)	mg KOH/g	ASTM D974*	0.70	**0.44**	0.26	0.44
MPC Varnish Potential	Scale	ASTM D7843(m)*	>15	▲ **19**	⬢ 43	9
