OIL ANALYSIS REPORT

Area
SHARP BUS LINES
Machine Id
INTERNATIONAL 4DRBUSKPOEB457143
Component
Diesel Engine
Fluid
PETRO CANADA DURON-E 15W40 (--- GAL)

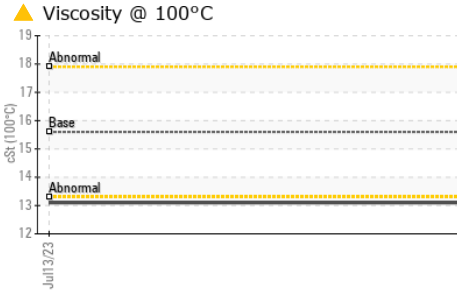
Viscosity @ 100°C

Fuel is present in the oil and is lowering the viscosity. The oil is no longer serviceable due to the presence of contaminants.

We advise that you check the fuel injection system. The oil change at the time of sampling has been noted. We recommend an early resample to monitor this condition.

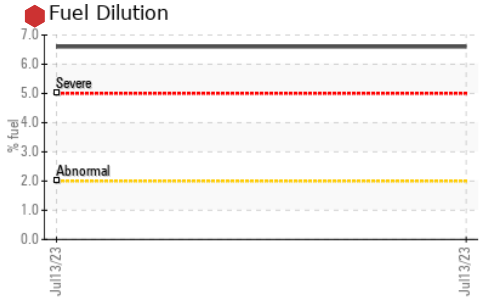
Fuel Dilution

There is a high amount of fuel present in the oil. Tests confirm the presence of fuel in the oil.

CONTAMINANTS		method	limit/base	current	history1	history2
Silicon	ppm	ASTM D5185(m)	>25	**3**	---	---
Sodium	ppm	ASTM D5185(m)		**2**	---	---
Potassium	ppm	ASTM D5185(m)	>20	**<1**	---	---
Fuel	%	ASTM D7593*	>2.0	**6.6**	---	---
