Customer Id: TERHAM
Sample No.: PC
Lab Number: 02573834
Test Package: MAR 2

OIL ANALYSIS REPORT

Area
Fwd Machinery Space [450164935]
Machine Id
Thruster Aft Port - Steering Tube Seal (S/N Sample Tag CL-06002-S5)
Component
Steering
Fluid
CASTROL ALPHA SP150 (35 LTR)

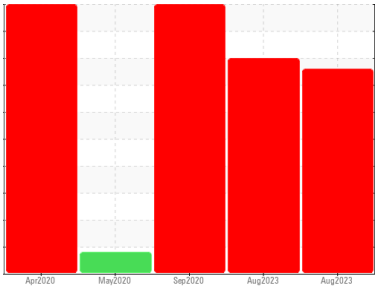
Sample Rating Trend

Sample Status				SEVERE	SEVERE	SEVERE
Particles >4µm		ASTM D7647	>2500	**28125**	30533	328396
Particles >6µm		ASTM D7647	>640	**9254**	9290	135250
Particles >14µm		ASTM D7647	>80	**749**	737	5387
Particles >21µm		ASTM D7647	>20	**280**	199	1285
Oil Cleanliness		ISO 4406 (c)	>18/16/13	**22/20/17**	22/20/17	26/24/20

We advise that you check all areas where contaminants can enter the system. We advise that you perform a filter service, and use off-line filtration to improve the cleanliness of the system fluid. The air breather requires service. If unrated, we recommend that you replace with a suitable micron rated and/or desiccant air breather. If rated, we recommend that you service/replace the breather. Resample in 30-45 days to monitor this situation.

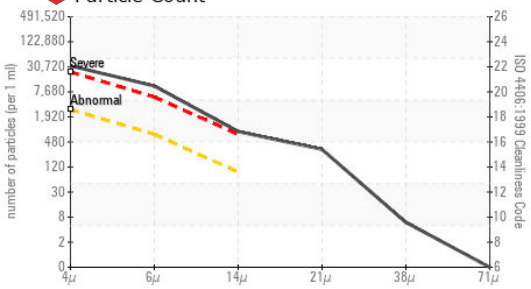
Particle Count

There is a high amount of particulates (2 to 100 microns in size) present in the fluid.

FLUID CLEANLINESS		method	limit/base	current	history1	history2
Particles >4µm		ASTM D7647	>2500	**28125**	30533	328396
Particles >6µm		ASTM D7647	>640	**9254**	9290	135250
Particles >14µm		ASTM D7647	>80	**749**	737	5387
Particles >21µm		ASTM D7647	>20	**280**	199	1285
Particles >38µm		ASTM D7647	>4	**5**	▲ 8	▲ 30
Particles >71µm		ASTM D7647	>3	**0**	1	0
Oil Cleanliness		ISO 4406 (c)	>18/16/13	**22/20/17**	22/20/17	26/24/20

We advise that you check all areas where contaminants can enter the system. We advise that you perform a filter service, and use off-line filtration to improve the cleanliness of the system fluid. The air breather requires service. If unrated, we recommend that you replace with a suitable micron rated and/or desiccant air breather. If rated, we recommend that you service/replace the breather. Resample in 30-45 days to monitor this situation.

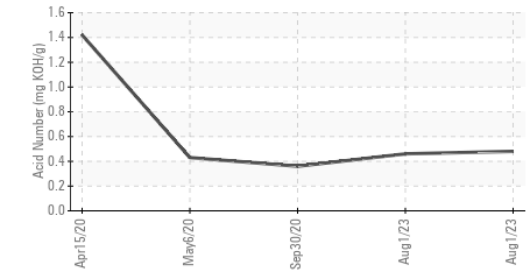
The AN level is acceptable for this fluid. The fluid is still serviceable provided that the contaminant(s) can be reduced to acceptable levels.

FLUID DEGRADATION		method	limit/base	current	history1	history2
Acid Number (AN)	mg KOH/g	ASTM D974*		**0.48**	0.46	0.36
