OIL ANALYSIS REPORT

Machine Id
6024
Component
Rear Diesel Engine
Fluid
PETRO CANADA DURON HP 15W40 (18 LTR)

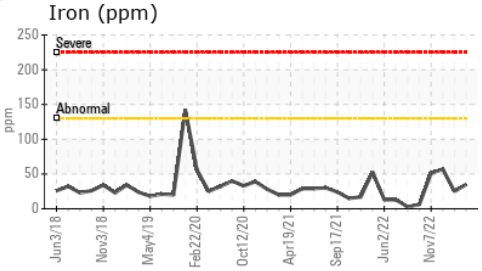
Iron (ppm)

Wear
Les taux d'usure de tous les composants sont normaux.

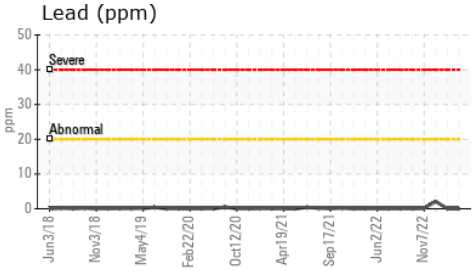
Lead (ppm)

Contamination
Elevated aluminum (Al) and/or lead (Pb) and potassium (K) levels in your metals analysis are likely a result of solder flux release into the lubricant and is common on new equipment/components. Il n`y a aucun indice de contamination dans l'huile.

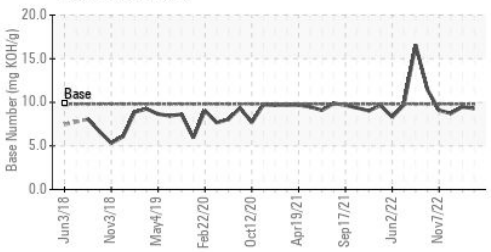
Base Number

Fluid Condition
Le résultat pour le BN indique que la réserve d'alcalinité est acceptable pour l'huile. L'état de l'huile permet d'en prolonger l'utilisation.
