Customer Id: TERHAM
Sample No.: PC0052589
Lab Number: 02582136
Test Package: MAR 2

OIL ANALYSIS REPORT

Area
Cranes
Machine Id
Crane - Mid - Hydraulic System (Reservoir) (S/N Sample Tag MA-04002-S4)
Component
Hydraulic System
Fluid
PETRO CANADA ATF DEXRON III/MERCON (800 LTR)

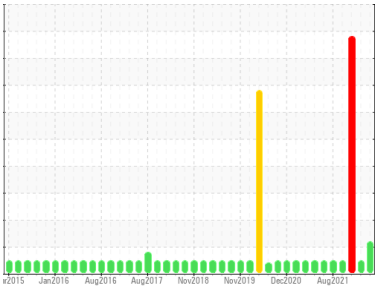
Sample Rating Trend

Sample Status				ABNORMAL	NORMAL	SEVERE
Particles >4µm		ASTM D7647	>5000	▲ **10892**	2088	⬢ 45175
Particles >6µm		ASTM D7647	>1300	▲ **2456**	423	⬢ 15067
Oil Cleanliness		ISO 4406 (c)	>19/17/14	▲ **21/18/14**	18/16/13	⬢ 23/21/16
PrtFilter

We recommend you service the filters on this component. We recommend an early resample to monitor this condition.

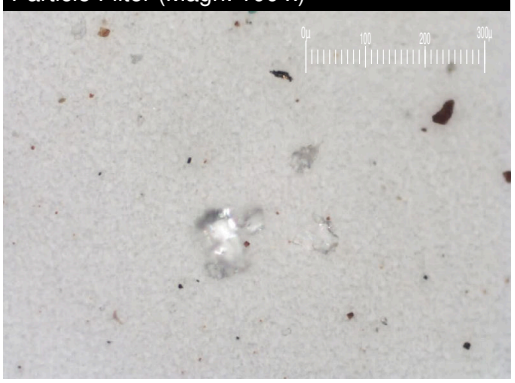
Particle Filter (Magn: 100 x)

There is a moderate amount of silt (particulates < 14 microns in size) present in the oil. The system cleanliness is above the acceptable limit for the target ISO 4406 cleanliness code.

We recommend you service the filters on this component. We recommend an early resample to monitor this condition.

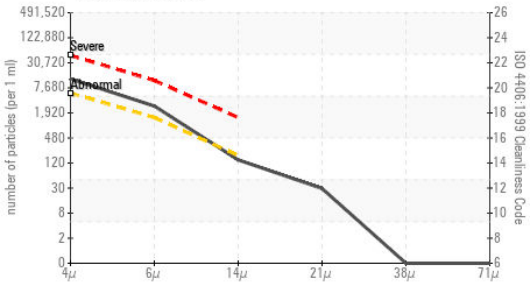
Particle Count

FLUID CLEANLINESS		method	limit/base	current	history1	history2
Particles >4µm		ASTM D7647	>5000	▲ **10892**	2088	⬢ 45175
Particles >6µm		ASTM D7647	>1300	▲ **2456**	423	⬢ 15067
Particles >14µm		ASTM D7647	>160	**126**	43	▲ 420
Particles >21µm		ASTM D7647	>40	**26**	13	▲ 65
Particles >38µm		ASTM D7647	>10	**0**	1	4
Particles >71µm		ASTM D7647	>3	**0**	0	1
Oil Cleanliness		ISO 4406 (c)	>19/17/14	▲ **21/18/14**	18/16/13	⬢ 23/21/16

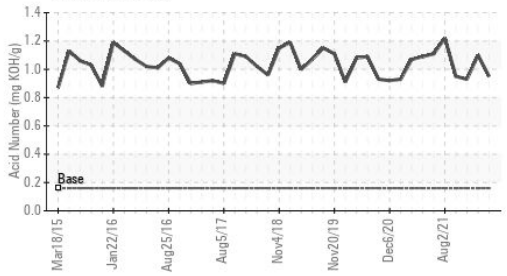
The AN level is acceptable for this fluid. The oil is still serviceable provided that the contaminant(s) can be reduced to acceptable levels.

FLUID DEGRADATION		method	limit/base	current	history1	history2
Acid Number (AN)	mg KOH/g	ASTM D974*	0.16	**0.95**	1.10	0.93
