Customer Id: TERHAM
Sample No.: PC0061639
Lab Number: 02582287
Test Package: MAR 2

OIL ANALYSIS REPORT

Area
Cranes
Machine Id
Crane - Mid Ship Slewing Gearbox #1 (S/N Sample Tag MA-04002-S7)
Component
Gearbox
Fluid
PETRO CANADA GEARLUBE TOS 80W90 (33 LTR)

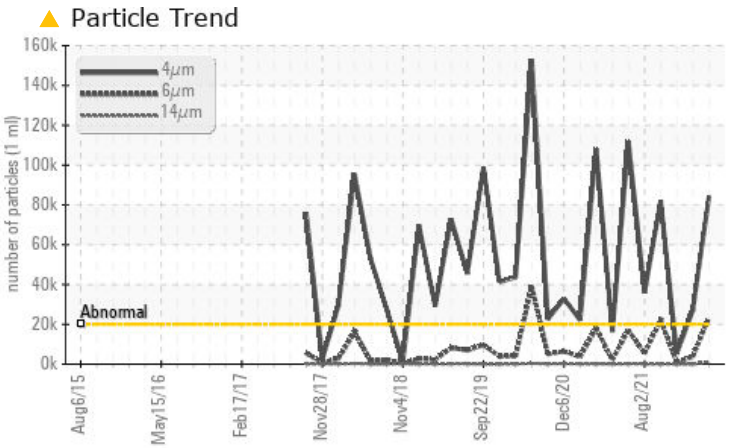
COMPONENT CONDITION SUMMARY

Sample Status				ATTENTION	NORMAL	ABNORMAL
Particles >14µm		ASTM D7647	>640	▲ **1030**	41	31
Particles >21µm		ASTM D7647	>160	▲ **232**	8	7
Oil Cleanliness		ISO 4406 (c)	>21/19/16	▲ **24/22/17**	22/19/13	20/17/12

Contamination
There is a moderate amount of silt (particulates < 14 microns in size) present in the oil.

Fluid Condition
The AN level is acceptable for this fluid. The oil is still serviceable provided that the contaminant(s) can be reduced to acceptable levels.

We recommend you service the filters on this component. We recommend an early resample to monitor this condition.

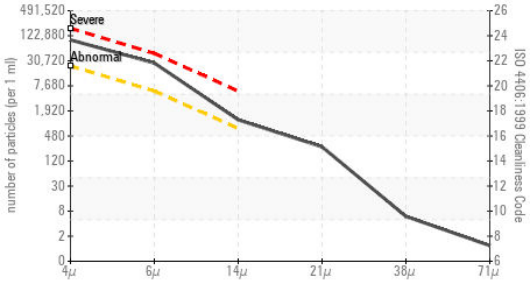
Particle Count

FLUID CLEANLINESS		method	limit/base	current	history1	history2
Particles >4µm		ASTM D7647	>20000	**84298**	27236	5338
Particles >6µm		ASTM D7647	>5000	**23554**	3855	957
Particles >14µm		ASTM D7647	>640	▲ **1030**	41	31
Particles >21µm		ASTM D7647	>160	▲ **232**	8	7
Particles >38µm		ASTM D7647	>40	**5**	0	1
Particles >71µm		ASTM D7647	>10	**1**	0	0
Oil Cleanliness		ISO 4406 (c)	>21/19/16	▲ **24/22/17**	22/19/13	20/17/12

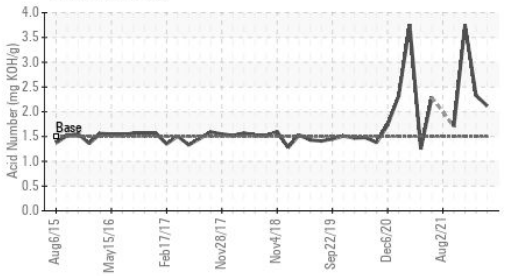
FLUID DEGRADATION		method	limit/base	current	history1	history2
Acid Number (AN)	mg KOH/g	ASTM D974*	1.5	**2.12**	2.33	▲ 3.75
