PROBLEM SUMMARY

Area
Aft Machinery Space [450188488]
Machine Id
Thruster Aft Center - Seal Oil System (S/N Sample Tag CL-06001-S3)
Component
Sealing System
Fluid
PETRO CANADA ENERGOL GR-XP ISO 150 (65 LTR)

OIL ANALYSIS REPORT

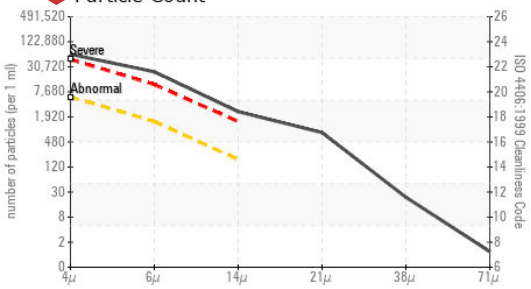
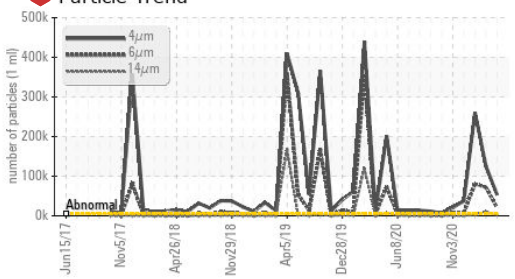
Particle Count

There is a high amount of particulates (2 to 100 microns in size) present in the fluid.

FLUID CLEANLINESS		method	limit/base	current	history1	history2
Particles >4µm		ASTM D7647	>5000	⬢ **53288**	⬢ 124763	⬢ 260851
Particles >6µm		ASTM D7647	>1300	⬢ **20211**	⬢ 71826	⬢ 80435
Particles >14µm		ASTM D7647	>160	⬢ **2241**	⬢ 10767	⬢ 1873
Particles >21µm		ASTM D7647	>40	⬢ **710**	⬢ 3153	▲ 282
Particles >38µm		ASTM D7647	>10	▲ **20**	⬢ 126	1
Particles >71µm		ASTM D7647	>3	**1**	▲ 10	0
Oil Cleanliness		ISO 4406 (c)	>19/17/14	⬢ **23/22/18**	⬢ 24/23/21	⬢ 25/24/18

We advise that you check all areas where contaminants can enter the system. We advise that you perform a filter service, and use off-line filtration to improve the cleanliness of the system fluid. The air breather requires service. If unrated, we recommend that you replace with a suitable micron rated and/or desiccant air breather. If rated, we recommend that you service/replace the breather. Resample in 30-45 days to monitor this situation.

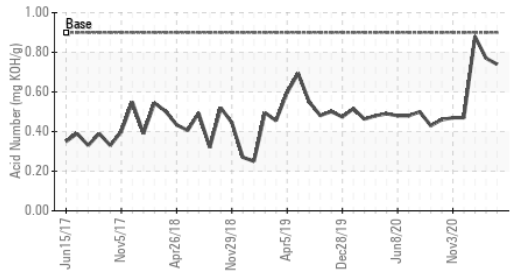
Acid Number

The AN level is acceptable for this fluid. The fluid is still serviceable provided that the contaminant(s) can be reduced to acceptable levels.
