OIL ANALYSIS REPORT

Machine Id
831025
Component
Hydraulic System
Fluid
PETRO CANADA HYDREX MV 32 (--- GAL)

SAMPLE INFORMATION		method	limit/base	current	history1	history2
Sample Number		Client Info		**PC0071762**	---	---
Sample Date		Client Info		**28 Aug 2023**	---	---
Machine Age	kms	Client Info		**0**	---	---
Oil Age	kms	Client Info		**0**	---	---
Oil Changed		Client Info		**N/A**	---	---
Sample Status				**SEVERE**	---	---

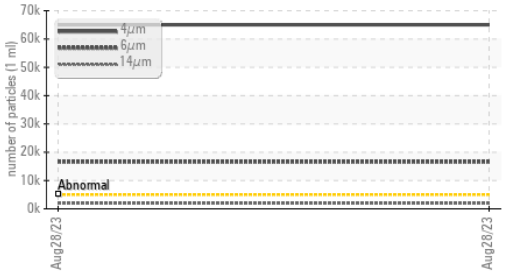
Particle Trend

Il y a une quantité élevée de matières particulaires (2 à 100 µm de taille) présente dans l'huile.

FLUID CLEANLINESS		method	limit/base	current	history1	history2
Particles >4µm		ASTM D7647	>5000	**65014**	---	---
Particles >6µm		ASTM D7647	>1300	**16617**	---	---
Particles >14µm		ASTM D7647	>160	**1916**	---	---
Particles >21µm		ASTM D7647	>40	**589**	---	---
Particles >38µm		ASTM D7647	>10	**13**	---	---
Particles >71µm		ASTM D7647	>3	**1**	---	---
Oil Cleanliness		ISO 4406 (c)	>19/17/14	**23/21/18**	---	---

Nous vous recommandons de vérifier tous les endroits par lesquels des contaminants peuvent pénétrer dans le système. Nous vous recommandons de remplacer le filtre et d'utiliser un système de filtrage hors-ligne afin d'améliorer la propreté du fluide. Le reniflard d`air doit être réparé. S`il n`est pas classé, nous vous recommandons de le remplacer par un reniflard à air adapté au micron et / ou au dessicant. Si évalué, nous vous recommandons de réparer / remplacer le reniflard. Échantillonner de nouveau dans 30 à 45 jours afin de contrôler la situation.
