OIL ANALYSIS REPORT

Area
SHARP BUS LINES
Machine Id
INTERNATIONAL 1153
Component
Diesel Engine
Fluid
PETRO CANADA DURON HP 15W40 (--- GAL)

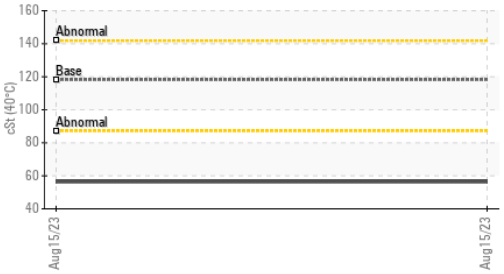
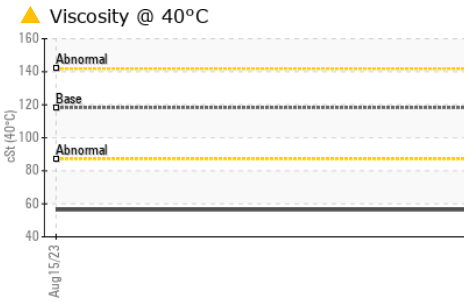
Viscosity @ 40°C

Fuel is present in the oil and is lowering the viscosity. The oil is no longer serviceable due to the presence of contaminants.

FLUID PROPERTIES		method	limit/base	current	history1	history2
Visc @ 40°C	cSt	ASTM D7279(m)	118.2	▲ **56.4**	---	---
Visc @ 100°C	cSt	ASTM D7279(m)	15.6	⬢ **9.8**	---	---
Viscosity Index (VI)	Scale	ASTM D2270*	139	**160**	---	---

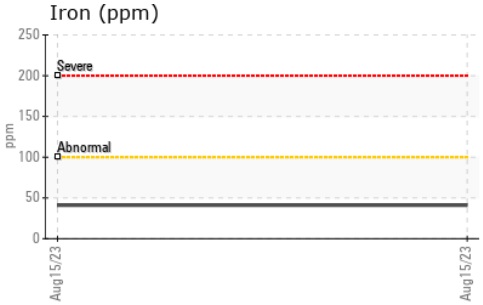
Iron (ppm)

All component wear rates are normal.

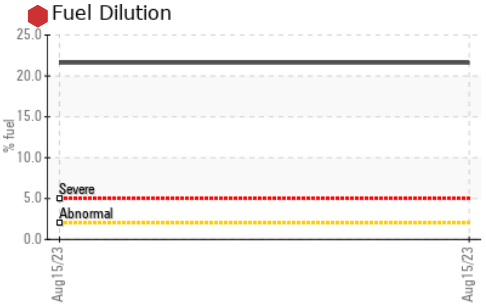
Fuel Dilution

There is a high amount of fuel present in the oil. Tests confirm the presence of fuel in the oil.

CONTAMINANTS		method	limit/base	current	history1	history2
Silicon	ppm	ASTM D5185(m)	>25	**4**	---	---
Sodium	ppm	ASTM D5185(m)		**4**	---	---
Potassium	ppm	ASTM D5185(m)	>20	**1**	---	---
Fuel	%	ASTM D7593*	>2.0	**21.6**	---	---

We advise that you check the fuel injection system. We recommend that you drain the oil from the component if this has not already been done. We recommend an early resample to monitor this condition.
