OIL ANALYSIS REPORT

Area
SHARP BUS LINES
Machine Id
INTERNATIONAL 1261
Component
Diesel Engine
Fluid
PETRO CANADA DURON HP 15W40 (--- GAL)

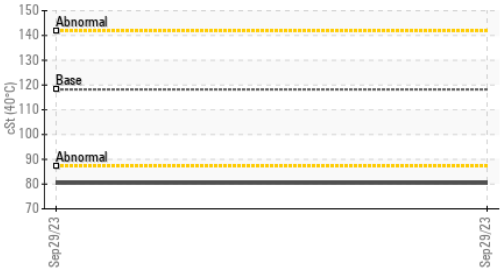
Viscosity @ 40°C

Fluid Condition
Fuel is present in the oil and is lowering the viscosity. The oil is no longer serviceable due to the presence of contaminants.

FLUID PROPERTIES		method	limit/base	current	history1	history2
Visc @ 40°C	cSt	ASTM D7279(m)	118.2	▲ **80.4**	---	---
Visc @ 100°C	cSt	ASTM D7279(m)	15.6	▲ **12.4**	---	---
Viscosity Index (VI)	Scale	ASTM D2270*	139	**151**	---	---

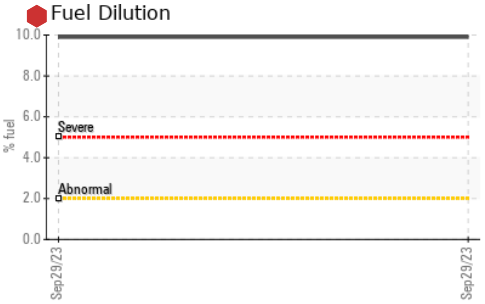
Fuel Dilution

Contamination
There is a high amount of fuel present in the oil. Tests confirm the presence of fuel in the oil.

CONTAMINANTS		method	limit/base	current	history1	history2
Silicon	ppm	ASTM D5185(m)	>18	**3**	---	---
Sodium	ppm	ASTM D5185(m)		**2**	---	---
Potassium	ppm	ASTM D5185(m)	>20	**0**	---	---
Fuel	%	ASTM D7593*	>2.0	**9.9**	---	---

Recommendation
We advise that you check the fuel injection system. The oil change at the time of sampling has been noted. We recommend an early resample to monitor this condition.
