OIL ANALYSIS REPORT

Machine Id
801026
Component
Diesel Engine
Fluid
PETRO CANADA DURON SHP 15W40 (22 LTR)

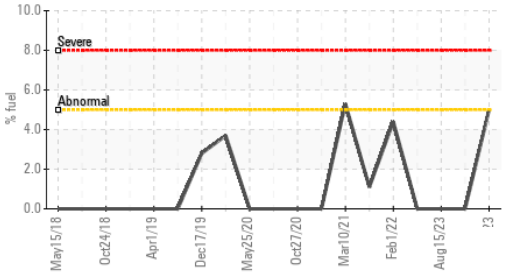
Fuel Dilution

Elevated aluminum (Al) and/or lead (Pb) and potassium (K) levels in your metals analysis are likely a result of solder flux release into the lubricant and is common on new equipment/components. There is a moderate amount of fuel present in the oil. Tests confirm the presence of fuel in the oil.

Fuel is present in the oil and is lowering the viscosity. The oil is no longer serviceable due to the presence of contaminants.

CONTAMINANTS		method	limit/base	current	history1	history2
Silicon	ppm	ASTM D5185(m)	>20	**8**	5	14
Sodium	ppm	ASTM D5185(m)		**9**	6	11
Potassium	ppm	ASTM D5185(m)	>20	**10**	6	25
Fuel	%	ASTM D7593*	>5	▲ **5**	<1.0	<1.0

The oil change at the time of sampling has been noted. We recommend an early resample to monitor this condition.

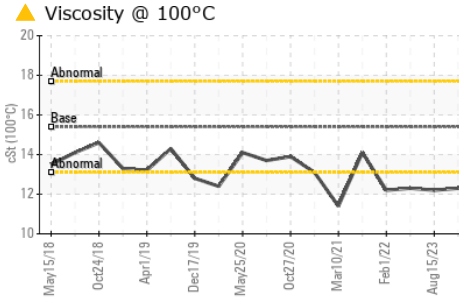
Viscosity @ 100°C

FLUID PROPERTIES		method	limit/base	current	history1	history2
Visc @ 100°C	cSt	ASTM D7279(m)	15.4	▲ **12.6**	12.3	12.2
