OIL ANALYSIS REPORT

Machine Id
NO UNIT PC0048710
Component
Hydraulic System
Fluid
NOT GIVEN (--- GAL)

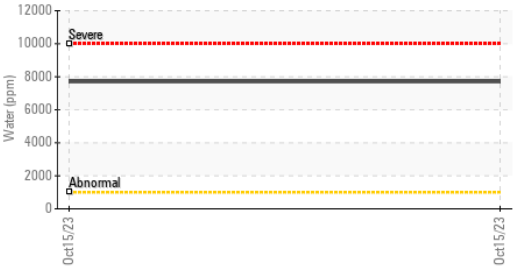
Water (KF)

There is a moderate concentration of water present in the oil.

CONTAMINANTS		method	limit/base	current	history1	history2
Silicon	ppm	ASTM D5185(m)	>20	**12**	---	---
Sodium	ppm	ASTM D5185(m)		**2**	---	---
Potassium	ppm	ASTM D5185(m)	>20	**<1**	---	---
Water	%	ASTM D6304*	>0.1	**0.770**	---	---
ppm Water	ppm	ASTM D6304*	>1000	**7704.1**	---	---

We advise that you check for the source of water entry. Check seals and/or filters for points of contaminant entry. We recommend that you drain the oil from the component if this has not already been done. We recommend an early resample to monitor this condition. Please specify the component make and model with your next sample. Please specify the brand, type, and viscosity of the oil on your next sample. NOTE: Please provide information regarding reservoir capacity, filter type and micron rating with next sample. Please contact your representative for information regarding the proper sampling kits for your service. NOTE: We recommend using MOB 2 test kits, this testkit includes Particle Count to determine the ISO cleanliness of the fluid.

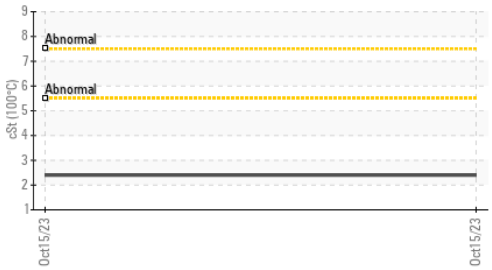
Viscosity @ 100°C

FLUID PROPERTIES		method	limit/base	current	history1	history2
Visc @ 40°C	cSt	ASTM D7279(m)		**58.8**	---	---
Visc @ 100°C	cSt	ASTM D7279(m)		**2.4**	---	---
