OIL ANALYSIS REPORT

Area
SHARP BUS LINES
Machine Id
INTERNATIONAL 1369
Component
Diesel Engine
Fluid
PETRO CANADA 15W40 (--- GAL)

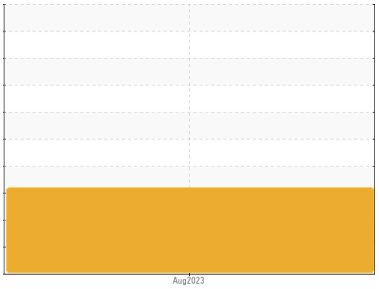
Sample Rating Trend

GLYCOL

Wear
Aluminum ppm levels are abnormal. Piston wear is indicated.

Contamination
Water treatment chemicals present, indicating slow coolant leak. Test for glycol is negative.

Recommendation
Check for low coolant level. The oil change at the time of sampling has been noted. We recommend an early resample to monitor this condition.
