OIL ANALYSIS REPORT

Area
SHARP BUS LINES
Machine Id
INTERNATIONAL 1368
Component
Diesel Engine
Fluid
PETRO CANADA 15W40 (--- GAL)

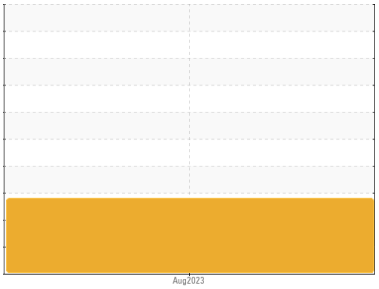
Sample Rating Trend

There is a high amount of fuel present in the oil. Tests confirm the presence of fuel in the oil.

Fuel is present in the oil and is lowering the viscosity. The oil is no longer serviceable due to the presence of contaminants.

We advise that you check the fuel injection system. The oil change at the time of sampling has been noted. We recommend an early resample to monitor this condition.

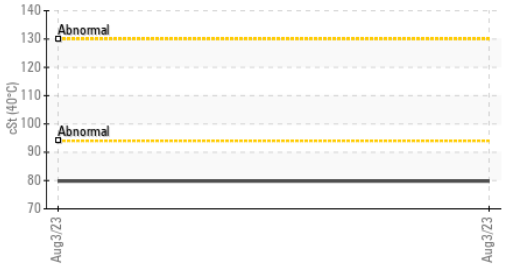
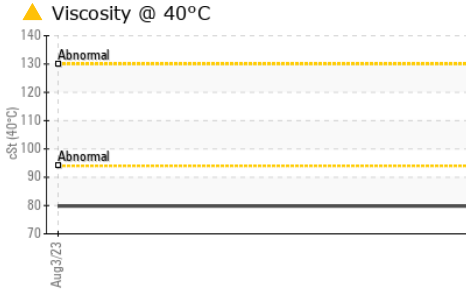
Viscosity @ 40°C

FLUID PROPERTIES		method	limit/base	current	history1	history2
Visc @ 40°C	cSt	ASTM D7279(m)		▲ **79.8**	---	---
Visc @ 100°C	cSt	ASTM D7279(m)		▲ **12.1**	---	---
Viscosity Index (VI)	Scale	ASTM D2270*		**147**	---	---

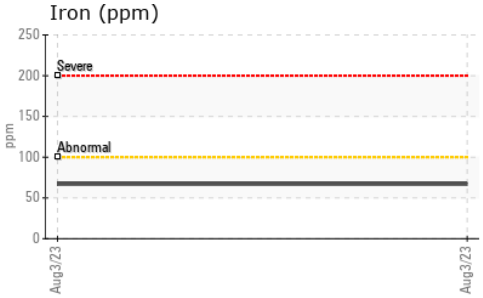
Iron (ppm)

All component wear rates are normal.

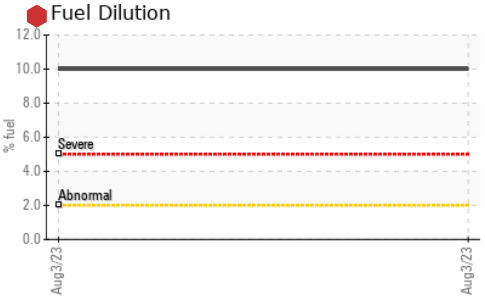
Fuel Dilution

CONTAMINANTS		method	limit/base	current	history1	history2
Silicon	ppm	ASTM D5185(m)	>25	**4**	---	---
Sodium	ppm	ASTM D5185(m)		**2**	---	---
Potassium	ppm	ASTM D5185(m)	>20	**<1**	---	---
Fuel	%	ASTM D7593*	>2.0	**10**	---	---
