OIL ANALYSIS REPORT

Area
SHARP BUS LINES
Machine Id
INTERNATIONAL 1340
Component
Diesel Engine
Fluid
PETRO CANADA 15W40 (--- GAL)

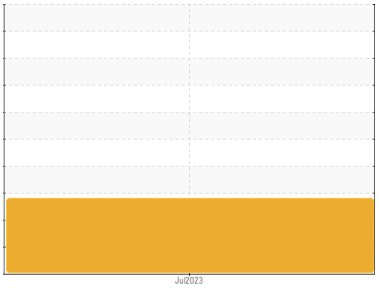
Sample Rating Trend

There is a high amount of fuel present in the oil. Tests confirm the presence of fuel in the oil.

Fuel is present in the oil and is lowering the viscosity. The oil is no longer serviceable due to the presence of contaminants.

We advise that you check the fuel injection system. The oil change at the time of sampling has been noted. We recommend an early resample to monitor this condition.

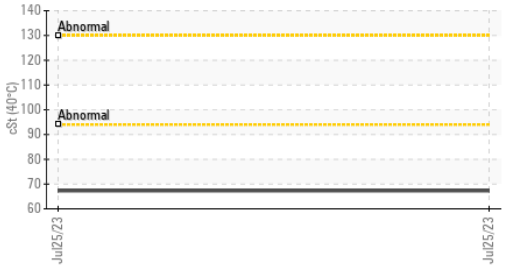
Viscosity @ 40°C

FLUID PROPERTIES		method	limit/base	current	history1	history2
Visc @ 40°C	cSt	ASTM D7279(m)		▲ **67.3**	---	---
Visc @ 100°C	cSt	ASTM D7279(m)		▲ **10.8**	---	---
Viscosity Index (VI)	Scale	ASTM D2270*		**150**	---	---

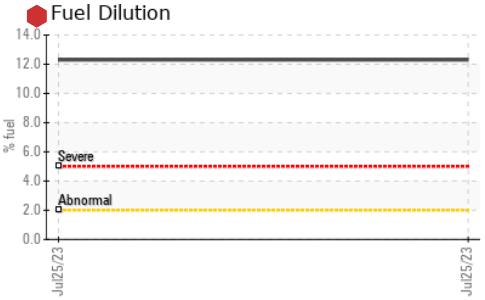
Fuel Dilution

CONTAMINANTS		method	limit/base	current	history1	history2
Silicon	ppm	ASTM D5185(m)	>25	**2**	---	---
Sodium	ppm	ASTM D5185(m)		**2**	---	---
Potassium	ppm	ASTM D5185(m)	>20	**<1**	---	---
Fuel	%	ASTM D7593*	>2.0	**12.3**	---	---
