OIL ANALYSIS REPORT

Area
SHARP BUS LINES
Machine Id
INTERNATIONAL 1323
Component
Diesel Engine
Fluid
PETRO CANADA DURON HP 15W40 (--- GAL)

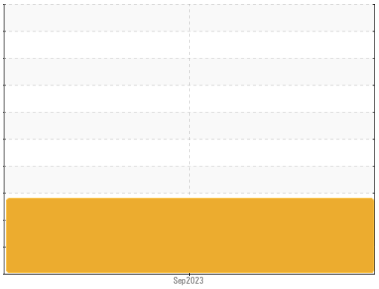
Sample Rating Trend

Contamination
There is a high amount of fuel present in the oil. Tests confirm the presence of fuel in the oil.

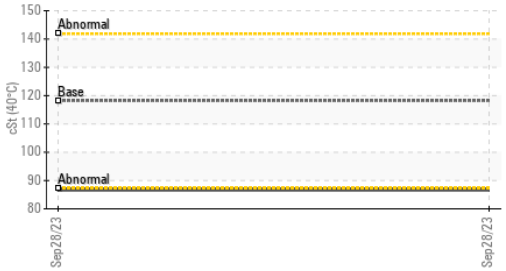
Viscosity @ 40°C

Fluid Condition
Fuel is present in the oil and is lowering the viscosity. The oil is no longer serviceable due to the presence of contaminants.

FLUID PROPERTIES		method	limit/base	current	history1	history2
Visc @ 40°C	cSt	ASTM D7279(m)	118.2	▲ **86.7**	---	---
Visc @ 100°C	cSt	ASTM D7279(m)	15.6	▲ **12.9**	---	---
Viscosity Index (VI)	Scale	ASTM D2270*	139	**147**	---	---

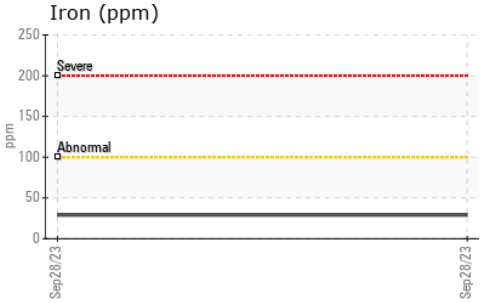
Iron (ppm)

Wear
All component wear rates are normal.

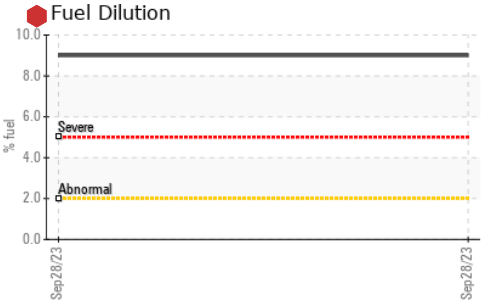
Fuel Dilution

CONTAMINANTS		method	limit/base	current	history1	history2
Silicon	ppm	ASTM D5185(m)	>25	**4**	---	---
Sodium	ppm	ASTM D5185(m)		**2**	---	---
Potassium	ppm	ASTM D5185(m)	>20	**0**	---	---
Fuel	%	ASTM D7593*	>2.0	**9**	---	---

Recommendation
We advise that you check the fuel injection system. The oil change at the time of sampling has been noted. We recommend an early resample to monitor this condition.
