OIL ANALYSIS REPORT

Area
TEAM 1
Machine Id
160130 Scrubber ID Fan Inboard Bearing
Component
Inboard Bearing
Fluid
PETRO CANADA TURBOFLO R&O 150 (1 GAL)

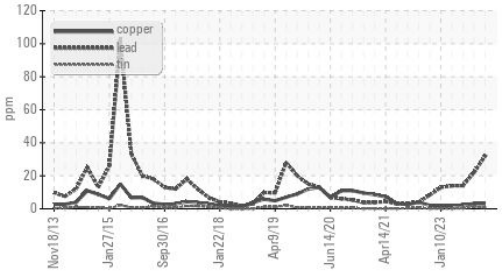
Non-ferrous Metals

Lead ppm levels are abnormal. Iron ppm levels are noted. Bearing wear is indicated. The low ferrous density (PQ) index indicates the wear metal levels are due to corrosion.

We recommend that you drain the oil from the component if this has not already been done. We recommend an early resample to monitor this condition.

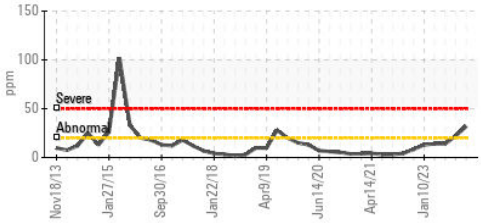
Lead (ppm)

The oil is no longer serviceable as a result of the abnormal and/or severe wear.
