OIL ANALYSIS REPORT

Machine Id
701021
Component
Diesel Engine
Fluid
PETRO CANADA DURON SHP 15W40 (22 LTR)

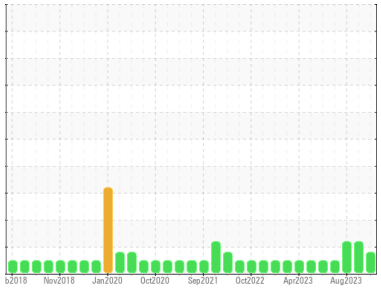
Sample Rating Trend

Elevated aluminum (Al) and/or lead (Pb) and potassium (K) levels in your metals analysis are likely a result of solder flux release into the lubricant and is common on new equipment/components. There is a moderate amount of fuel present in the oil. Tests confirm the presence of fuel in the oil.

The oil is no longer serviceable due to the presence of contaminants.

The oil change at the time of sampling has been noted. We recommend an early resample to monitor this condition.
