Customer Id: TERHAM
Sample No.: PC0052813
Lab Number: 02599123
Test Package: MAR 2

OIL ANALYSIS REPORT

Area
Fwd Machinery Space
Machine Id
Thruster Aft Port - Steering Tube Seal (S/N Sample Tag CL-06002-S5)
Component
Steering
Fluid
CASTROL ALPHA SP150 (35 LTR)

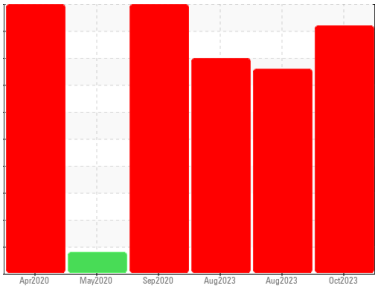
Sample Rating Trend

Sample Status				**SEVERE**	SEVERE	SEVERE
Iron	ppm	ASTM D5185(m)	>50	▲ **66**	1	1
Chromium	ppm	ASTM D5185(m)	>15	▲ **13**	0	0
Nickel	ppm	ASTM D5185(m)	>5	▲ **8**	0	0
Phosphorus	ppm	ASTM D5185(m)	330	▲ **165**	313	184
Particles >4µm		ASTM D7647	>2500	⬢ **141470**	⬢ 28125	⬢ 30533
Particles >6µm		ASTM D7647	>640	⬢ **72521**	⬢ 9254	⬢ 9290
Particles >14µm		ASTM D7647	>80	⬢ **1184**	⬢ 749	⬢ 737
Particles >21µm		ASTM D7647	>20	▲ **138**	⬢ 280	⬢ 199
Particles >38µm		ASTM D7647	>4	▲ **7**	5	▲ 8
Oil Cleanliness		ISO 4406 (c)	>18/16/13	⬢ **24/23/17**	⬢ 22/20/17	⬢ 22/20/17

We advise that you check all areas where contaminants can enter the system. We recommend that you drain the fluid from the component if this has not already been done. The air breather requires service. If unrated, we recommend that you replace with a suitable micron rated and/or desiccant air breather. If rated, we recommend that you service/replace the breather. We recommend you service the filters on this component. Resample in 30-45 days to monitor this situation.

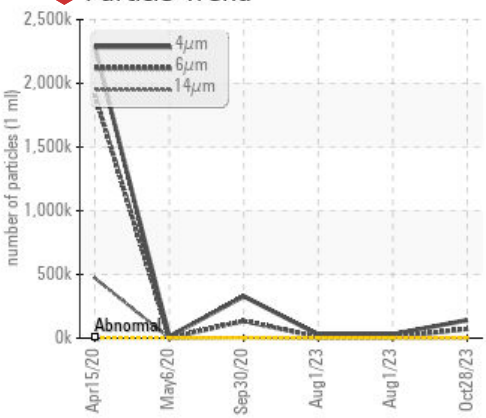
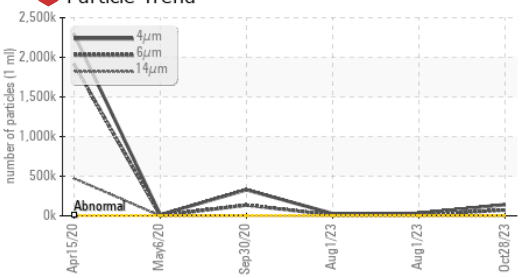
There is a high amount of particulates (2 to 100 microns in size) present in the fluid.

We advise that you check all areas where contaminants can enter the system. We recommend that you drain the fluid from the component if this has not already been done. The air breather requires service. If unrated, we recommend that you replace with a suitable micron rated and/or desiccant air breather. If rated, we recommend that you service/replace the breather. We recommend you service the filters on this component. Resample in 30-45 days to monitor this situation.

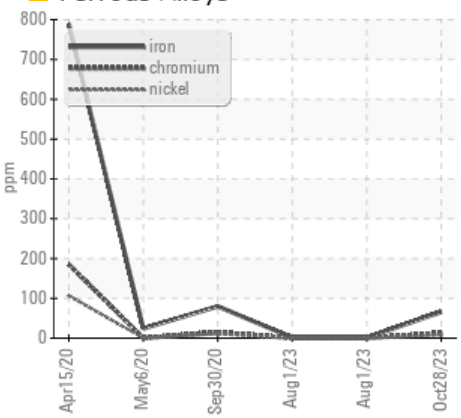
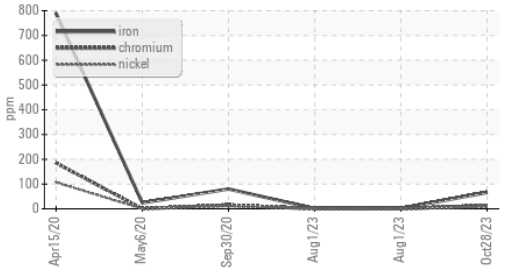
Iron and nickel ppm levels are abnormal. Chromium ppm levels are marginal.

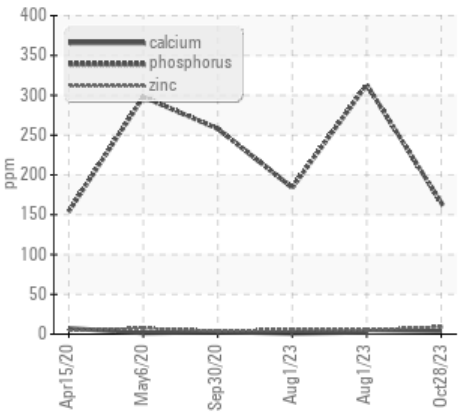
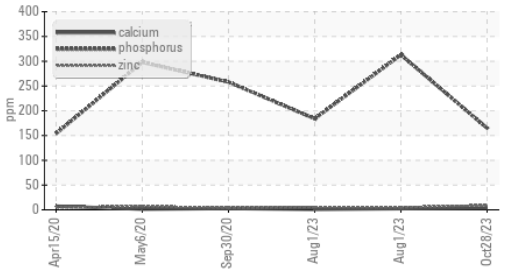
Additive levels indicate the addition of a different brand, or type of fluid. The AN level is acceptable for this fluid. The fluid is no longer serviceable as a result of the abnormal and/or severe wear. NOTE: The color of the oil is darker then previous samples.

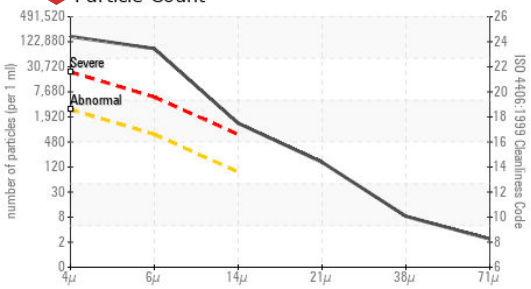
Particle Count

FLUID CLEANLINESS	method	limit/base	current	history1	history2
Particles >4µm	ASTM D7647	>2500	**141470**	28125	30533
Particles >6µm	ASTM D7647	>640	**72521**	9254	9290
Particles >14µm	ASTM D7647	>80	**1184**	749	737
Particles >21µm	ASTM D7647	>20	**138**	280	199
Particles >38µm	ASTM D7647	>4	**7**	5	8
Particles >71µm	ASTM D7647	>3	**2**	0	1
Oil Cleanliness	ISO 4406 (c)	>18/16/13	**24/23/17**	22/20/17	22/20/17

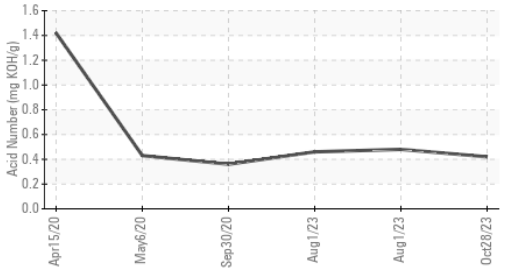
FLUID DEGRADATION		method	limit/base	current	history1	history2
Acid Number (AN)	mg KOH/g	ASTM D974*		**0.42**	0.48	0.46
