OIL ANALYSIS REPORT

Area
Aft Machinery Space
Machine Id
Thruster Aft Starboard - Lubrication System (S/N Sample Tag CL-06003-S1)
Component
Lube System
Fluid
PETRO CANADA ENERGOL GR-XP ISO 150 (5000 LTR)

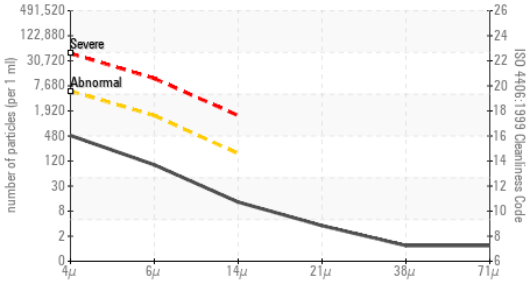
Particle Count

Contamination
The system cleanliness is acceptable for your target ISO 4406 cleanliness code. The system and fluid cleanliness is acceptable.

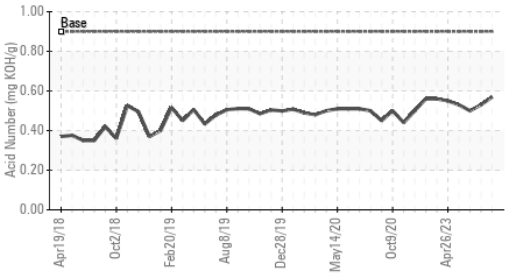
Acid Number

Fluid Condition
The AN level is acceptable for this fluid. The condition of the oil is suitable for further service.
