PROBLEM SUMMARY

Area
1440
Machine Id
1440-5512-4003 - COPPER REGRIND MILL
Component
Drive End Gear Reducer
Fluid
PETRO CANADA ENDURATEX EP 220 (55 GAL)

OIL ANALYSIS REPORT

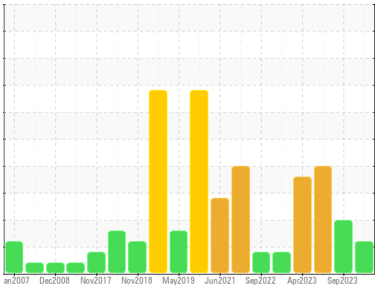
Sample Rating Trend

Sample Status				**ABNORMAL**	ABNORMAL	ABNORMAL
Particles >4µm		ASTM D7647	>20000	▲ **77124**	▲ 130219	▲ 132472
Particles >6µm		ASTM D7647	>5000	▲ **22745**	▲ 66632	▲ 37071
Oil Cleanliness		ISO 4406 (c)	>21/19/16	▲ **23/22/16**	▲ 24/23/19	▲ 24/22/17

We recommend you service the filters on this component. We recommend an early resample to monitor this condition.

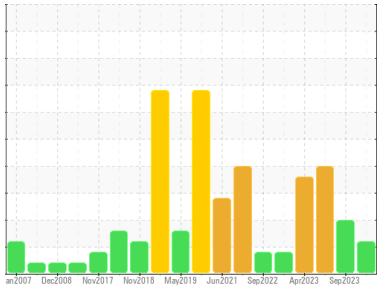
Sample Rating Trend

All component wear rates are normal.

We recommend you service the filters on this component. We recommend an early resample to monitor this condition.

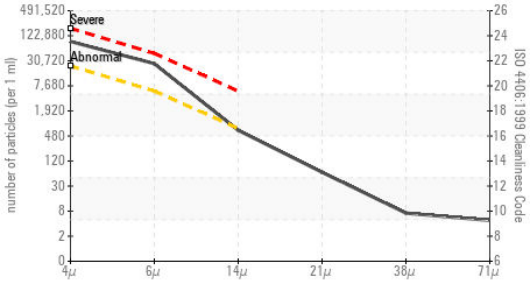
Particle Count

There is a moderate amount of silt (particulates < 14 microns in size) present in the oil.

FLUID CLEANLINESS		method	limit/base	current	history1	history2
Particles >4µm		ASTM D7647	>20000	▲ **77124**	▲ 130219	▲ 132472
Particles >6µm		ASTM D7647	>5000	▲ **22745**	▲ 66632	▲ 37071
Particles >14µm		ASTM D7647	>640	**578**	▲ 3505	▲ 1016
Particles >21µm		ASTM D7647	>160	**57**	▲ 483	82
Particles >38µm		ASTM D7647	>40	**6**	15	2
Particles >71µm		ASTM D7647	>10	**4**	9	0
Oil Cleanliness		ISO 4406 (c)	>21/19/16	▲ **23/22/16**	▲ 24/23/19	▲ 24/22/17

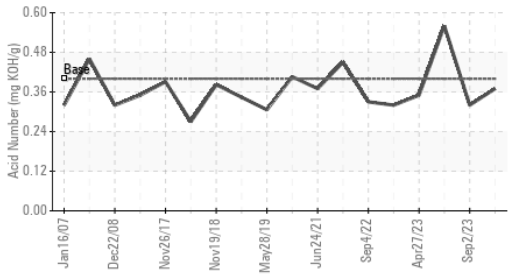
Viscosity of sample indicates oil is within ISO 320 range, advise investigate. The AN level is acceptable for this fluid. The oil is still serviceable provided that the contaminant(s) can be reduced to acceptable levels.

FLUID DEGRADATION		method	limit/base	current	history1	history2
Acid Number (AN)	mg KOH/g	ASTM D974*	0.40	**0.37**	0.32	0.56

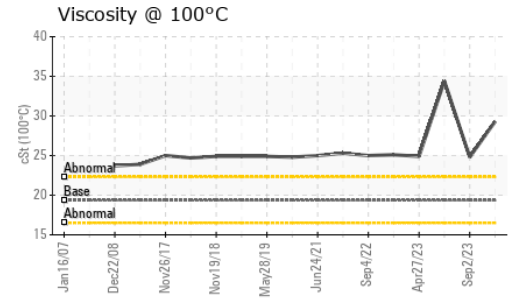
Viscosity @ 100°C

FLUID PROPERTIES		method	limit/base	current	history1	history2
Visc @ 40°C	cSt	ASTM D7279(m)	220	**326**	324	327
Visc @ 100°C	cSt	ASTM D7279(m)	19.35	**29.3**	24.8	34.4
Viscosity Index (VI)	Scale	ASTM D2270*	99	**122**	98	148
