OIL ANALYSIS REPORT

Machine Id
5217
Component
Gasoline Engine
Fluid
SAE 5W30 (--- GAL)

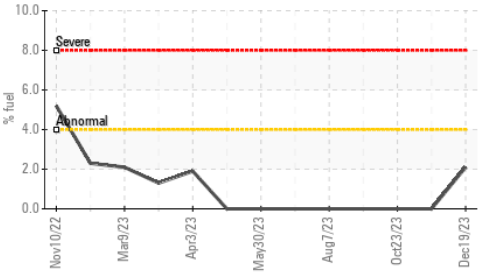
Fuel Dilution

Légère dilution de carburant dans l'huile. Aucun autre contaminant n'a été détecté dans l'huile.

Nous avons pris note que la vidange d`huile a été effectuée au moment de l`échantillonnage. Échantillonner de nouveau l'équipement au prochain intervalle de vidange afin d'en surveiller la condition. Aucune autre mesure corrective n'est recommandée pour l'instant.
