Customer Id: TERHAM
Sample No.: PC
Lab Number: 02605584
Test Package: MAR 2

OIL ANALYSIS REPORT

Area
Fwd Machinery Space [450234570]
Machine Id
Thruster Fwd Fore - Steering Tube Seal (S/N Sample Tag CL-06005-S5)
Component
Steering
Fluid
CASTROL ALPHA SP150 (35 LTR)

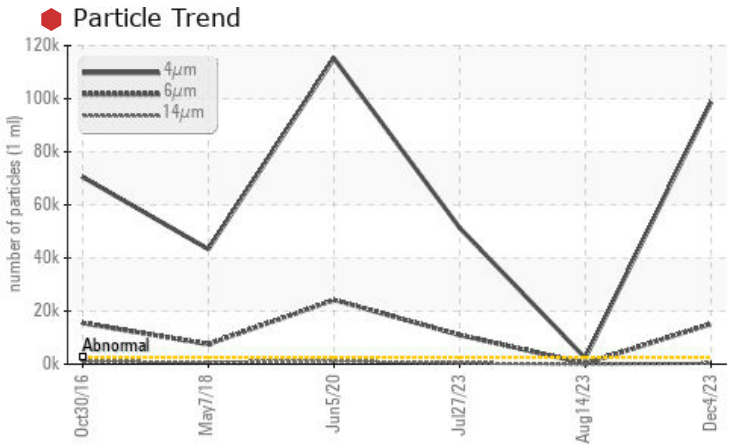
COMPONENT CONDITION SUMMARY

Sample Status				SEVERE	NORMAL	SEVERE
Particles >4µm		ASTM D7647	>2500	**98700**	2254	51313
Particles >6µm		ASTM D7647	>640	**15152**	232	10988
Particles >14µm		ASTM D7647	>80	**305**	3	392
Particles >21µm		ASTM D7647	>20	**46**	2	94
Oil Cleanliness		ISO 4406 (c)	>18/16/13	**24/21/15**	18/15/9	23/21/16

There is a high amount of particulates (2 to 100 microns in size) present in the fluid.

We advise that you check all areas where contaminants can enter the system. We advise that you perform a filter service, and use off-line filtration to improve the cleanliness of the system fluid. The air breather requires service. If unrated, we recommend that you replace with a suitable micron rated and/or desiccant air breather. If rated, we recommend that you service/replace the breather. Resample in 30-45 days to monitor this situation.

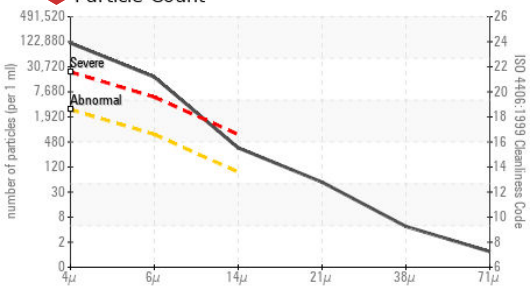
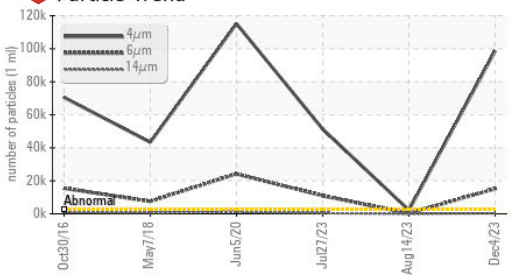
Particle Count

FLUID CLEANLINESS		method	limit/base	current	history1	history2
Particles >4µm		ASTM D7647	>2500	**98700**	2254	51313
Particles >6µm		ASTM D7647	>640	**15152**	232	10988
Particles >14µm		ASTM D7647	>80	**305**	3	392
Particles >21µm		ASTM D7647	>20	**46**	2	94
Particles >38µm		ASTM D7647	>4	**4**	0	9
Particles >71µm		ASTM D7647	>3	**1**	0	4
Oil Cleanliness		ISO 4406 (c)	>18/16/13	**24/21/15**	18/15/9	23/21/16

We advise that you check all areas where contaminants can enter the system. We advise that you perform a filter service, and use off-line filtration to improve the cleanliness of the system fluid. The air breather requires service. If unrated, we recommend that you replace with a suitable micron rated and/or desiccant air breather. If rated, we recommend that you service/replace the breather. Resample in 30-45 days to monitor this situation.

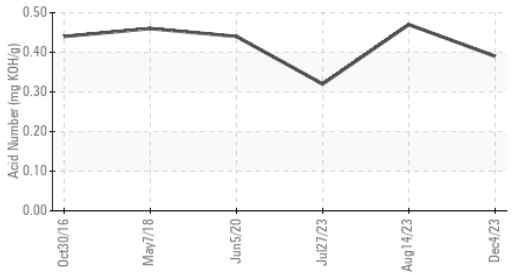
Acid Number

The AN level is acceptable for this fluid. The fluid is still serviceable provided that the contaminant(s) can be reduced to acceptable levels.
