PROBLEM SUMMARY

Machine Id
IMM #14 (S/N 2131042)
Component
Hydraulic System
Fluid
PETRO CANADA HYDREX AW 46 (2000 LTR)

Customer Id: ROPOAK
Sample No.: PC0080835
Lab Number: 02611521
Test Package: IND 2

OIL ANALYSIS REPORT

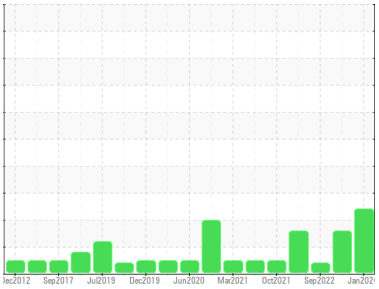
Sample Rating Trend

INSOLUBLES

Sample Status				**SEVERE**	SEVERE	ABNORMAL
Particles >4µm		ASTM D7647	>5000	▲ **15799**	▲ 10085	4701
Particles >6µm		ASTM D7647	>1300	▲ **2810**	997	654
Oil Cleanliness		ISO 4406 (c)	>19/17/14	▲ **21/19/15**	▲ 21/17/12	19/17/12
MPC Varnish Potential	Scale	ASTM D7843(m)*	>15	⬢ **58**	⬢ 45	▲ 30

We recommend you service the filters on this component. We recommend that you use electrostatic filtration to remove insolubles from the oil and to reduce the levels of varnish in the system. Alternatively draining a percentage of the oil and topping up with fresh oil (sweetening the oil) may provide a reduction in the varnish potential level. We recommend an early resample to monitor this condition.

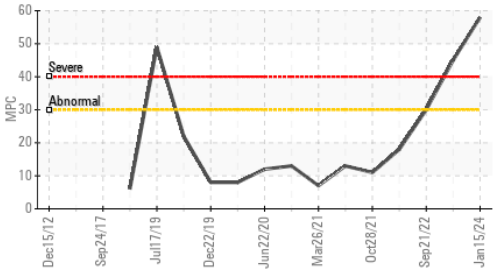
There is a moderate amount of silt (particulates < 14 microns in size) present in the oil. MPC (Membrane Patch Colorimetry) test indicates a high concentration of varnish present.

FLUID DEGRADATION		method	limit/base	current	history1	history2
Acid Number (AN)	mg KOH/g	ASTM D974*	0.70	**0.36**	0.40	0.32
MPC Varnish Potential	Scale	ASTM D7843(m)*	>15	**58**	45	30

We recommend you service the filters on this component. We recommend that you use electrostatic filtration to remove insolubles from the oil and to reduce the levels of varnish in the system. Alternatively draining a percentage of the oil and topping up with fresh oil (sweetening the oil) may provide a reduction in the varnish potential level. We recommend an early resample to monitor this condition.

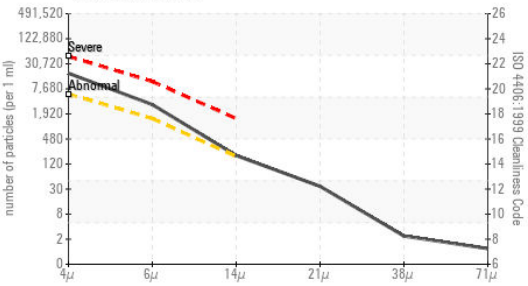
Particle Count

FLUID CLEANLINESS		method	limit/base	current	history1	history2
Particles >4µm		ASTM D7647	>5000	▲ **15799**	▲ 10085	4701
Particles >6µm		ASTM D7647	>1300	▲ **2810**	997	654
Particles >14µm		ASTM D7647	>160	▲ **169**	25	21
Particles >21µm		ASTM D7647	>40	**31**	5	4
Particles >38µm		ASTM D7647	>10	**2**	0	0
Particles >71µm		ASTM D7647	>3	**1**	0	0
Oil Cleanliness		ISO 4406 (c)	>19/17/14	▲ **21/19/15**	▲ 21/17/12	19/17/12

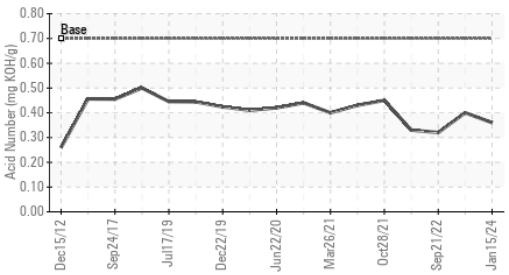
Acid Number

The AN level is acceptable for this fluid. The oil is still serviceable provided that the contaminant(s) can be reduced to acceptable levels.

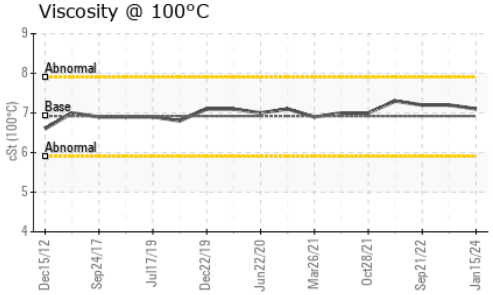
Viscosity @ 100°C

FLUID PROPERTIES		method	limit/base	current	history1	history2
Visc @ 40°C	cSt	ASTM D7279(m)	46.4	**44.7**	45.0	45.3
Visc @ 100°C	cSt	ASTM D7279(m)	6.92	**7.1**	7.2	7.2
Viscosity Index (VI)	Scale	ASTM D2270*	104	**118**	120	119
