Machine Id
IMM #23 (S/N 61020231)
Component
Hydraulic System
Fluid
PETRO CANADA HYDREX AW 46 (2000 LTR)

Customer Id: ROPOAK
Sample No.: PC0080869
Lab Number: 02611532
Test Package: IND 2

OIL ANALYSIS REPORT

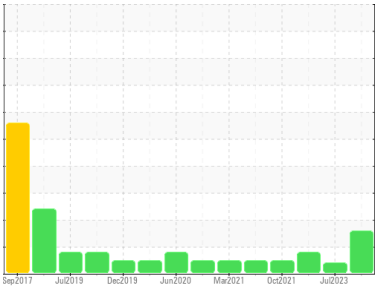
Sample Rating Trend

INSOLUBLES

Sample Status				SEVERE	ABNORMAL	SEVERE
MPC Varnish Potential	Scale	ASTM D7843(m)*	>15	45	31	55

We recommend you service the filters on this component. We recommend that you use electrostatic filtration to remove insolubles from the oil and to reduce the levels of varnish in the system. Alternatively draining a percentage of the oil and topping up with fresh oil (sweetening the oil) may provide a reduction in the varnish potential level. We recommend an early resample to monitor this condition.

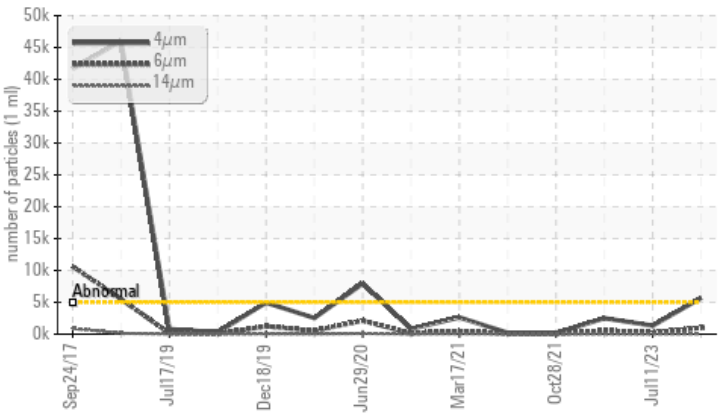
Particle Trend

FLUID CLEANLINESS		method	limit/base	current	history1	history2
Particles >4µm		ASTM D7647	>5000	▲ **5677**	1335	2504
Particles >6µm		ASTM D7647	>1300	**1000**	239	568
Particles >14µm		ASTM D7647	>160	**33**	11	22
Particles >21µm		ASTM D7647	>40	**6**	3	4
Particles >38µm		ASTM D7647	>10	**1**	0	0
Particles >71µm		ASTM D7647	>3	**0**	0	0
Oil Cleanliness		ISO 4406 (c)	>19/17/14	▲ **20/17/12**	18/15/11	19/16/12

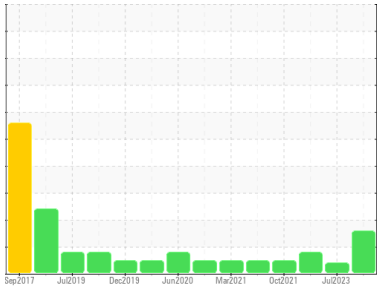
Sample Rating Trend

INSOLUBLES

There is a light amount of silt (particulates < 14 microns in size) present in the oil. MPC (Membrane Patch Colorimetry) test indicates a high concentration of varnish present.

We recommend you service the filters on this component. We recommend that you use electrostatic filtration to remove insolubles from the oil and to reduce the levels of varnish in the system. Alternatively draining a percentage of the oil and topping up with fresh oil (sweetening the oil) may provide a reduction in the varnish potential level. We recommend an early resample to monitor this condition.

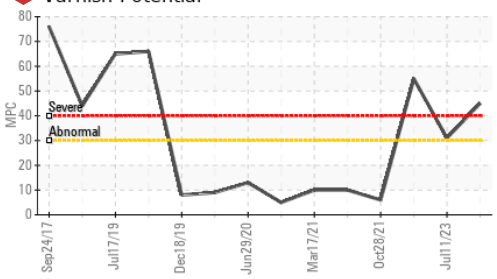
FLUID DEGRADATION		method	limit/base	current	history1	history2
Acid Number (AN)	mg KOH/g	ASTM D974*	0.70	**0.37**	0.45	0.24
MPC Varnish Potential	Scale	ASTM D7843(m)*	>15	**45**	31	55

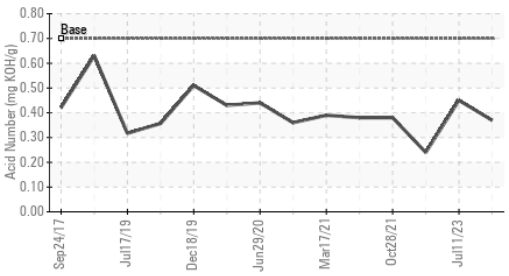
Acid Number

The AN level is acceptable for this fluid.
