Machine Id
IMM #24 (S/N 5142161)
Component
Hydraulic System
Fluid
PETRO CANADA HYDREX AW 46 (1000 LTR)

Customer Id: ROPOAK
Sample No.: PC0080870
Lab Number: 02611533
Test Package: IND 2

OIL ANALYSIS REPORT

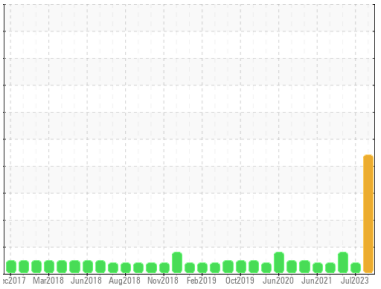
Sample Rating Trend

Sample Status				SEVERE	ABNORMAL	SEVERE
Particles >4µm		ASTM D7647	>5000	**62898**	2770	1488
Particles >6µm		ASTM D7647	>1300	**15026**	594	390
Oil Cleanliness		ISO 4406 (c)	>19/17/14	**23/21/15**	19/16/12	18/16/11
MPC Varnish Potential	Scale	ASTM D7843(m)*	>15	**26**	34	45

Check seals and/or filters for points of contaminant entry. The air breather requires service. If unrated, we recommend that you replace with a suitable micron rated and/or desiccant air breather. If rated, we recommend that you service/replace the breather. We recommend you service the filters on this component. Resample in 30-45 days to monitor this situation. No other corrective action is recommended at this time.

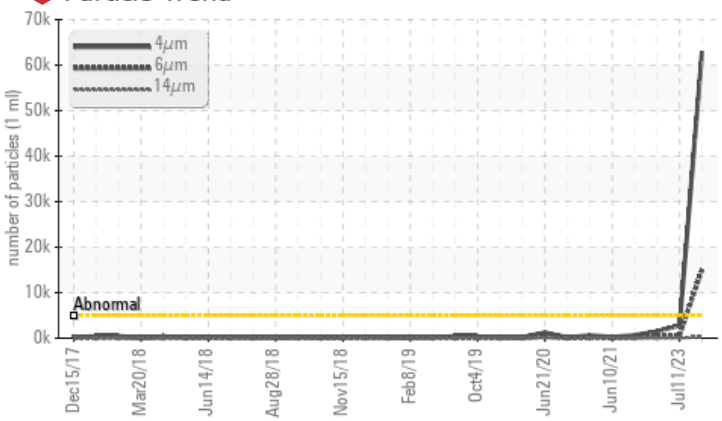
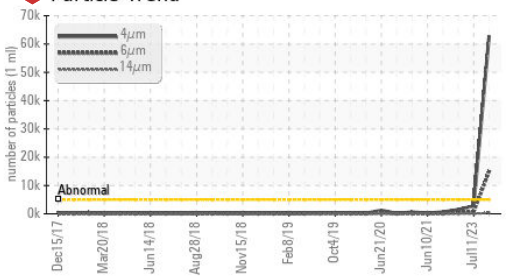
Particle Trend

There is a high amount of silt (particulates < 14 microns in size) present in the oil. MPC (Membrane Patch Colorimetry) test indicates a light concentration of varnish present.

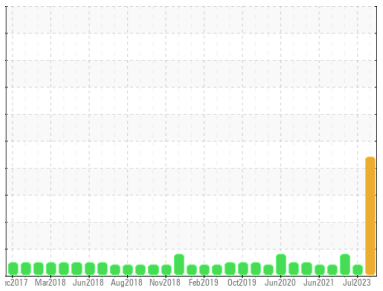
Sample Rating Trend

The AN level is acceptable for this fluid. The oil is still serviceable provided that the contaminant(s) can be reduced to acceptable levels.

Check seals and/or filters for points of contaminant entry. The air breather requires service. If unrated, we recommend that you replace with a suitable micron rated and/or desiccant air breather. If rated, we recommend that you service/replace the breather. We recommend you service the filters on this component. Resample in 30-45 days to monitor this situation. No other corrective action is recommended at this time.

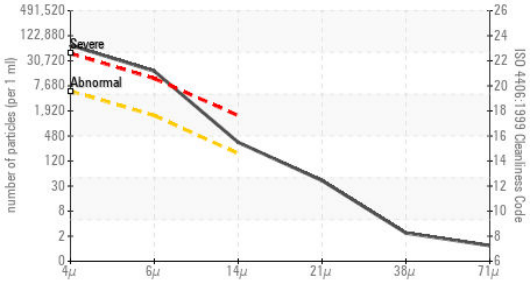
Particle Count

FLUID CLEANLINESS		method	limit/base	current	history1	history2
Particles >4µm		ASTM D7647	>5000	**62898**	2770	1488
Particles >6µm		ASTM D7647	>1300	**15026**	594	390
Particles >14µm		ASTM D7647	>160	**297**	34	14
Particles >21µm		ASTM D7647	>40	**36**	9	3
Particles >38µm		ASTM D7647	>10	**2**	1	0
Particles >71µm		ASTM D7647	>3	**1**	0	0
Oil Cleanliness		ISO 4406 (c)	>19/17/14	**23/21/15**	19/16/12	18/16/11
