Machine Id
IMM #7 (S/N 2175690)
Component
Hydraulic System
Fluid
PETRO CANADA HYDREX AW 46 (2000 LTR)

Customer Id: ROPOAK
Sample No.: PC0076986
Lab Number: 02611536
Test Package: IND 2

OIL ANALYSIS REPORT

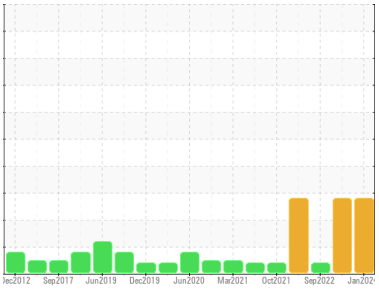
Sample Rating Trend

INSOLUBLES

Sample Status				SEVERE	SEVERE	MARGINAL
Particles >4µm		ASTM D7647	>5000	**56945**	40764	3671
Particles >6µm		ASTM D7647	>1300	**9942**	6230	599
Oil Cleanliness		ISO 4406 (c)	>19/17/14	**23/20/14**	23/20/12	19/16/12
MPC Varnish Potential	Scale	ASTM D7843(m)*	>15	**41**	55	22

Check seals and/or filters for points of contaminant entry. The air breather requires service. If unrated, we recommend that you replace with a suitable micron rated and/or desiccant air breather. If rated, we recommend that you service/replace the breather. We recommend you service the filters on this component. We recommend that you use electrostatic filtration to remove insolubles from the oil and to reduce the levels of varnish in the system. Alternatively draining a percentage of the oil and topping up with fresh oil (sweetening the oil) may provide a reduction in the varnish potential level. Resample in 30-45 days to monitor this situation.

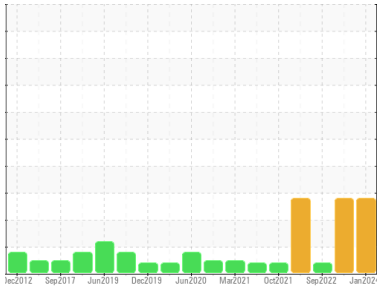
Sample Rating Trend

INSOLUBLES

There is a high amount of silt (particulates < 14 microns in size) present in the oil. MPC (Membrane Patch Colorimetry) test indicates a high concentration of varnish present.

The AN level is acceptable for this fluid. The oil is still serviceable provided that the contaminant(s) can be reduced to acceptable levels.

Check seals and/or filters for points of contaminant entry. The air breather requires service. If unrated, we recommend that you replace with a suitable micron rated and/or desiccant air breather. If rated, we recommend that you service/replace the breather. We recommend you service the filters on this component. We recommend that you use electrostatic filtration to remove insolubles from the oil and to reduce the levels of varnish in the system. Alternatively draining a percentage of the oil and topping up with fresh oil (sweetening the oil) may provide a reduction in the varnish potential level. Resample in 30-45 days to monitor this situation.

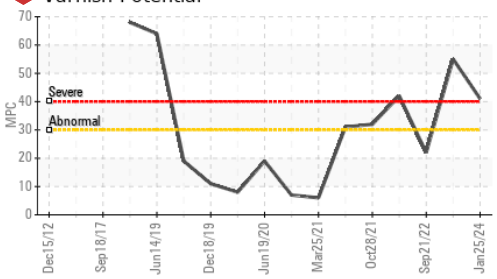
FLUID DEGRADATION		method	limit/base	current	history1	history2
Acid Number (AN)	mg KOH/g	ASTM D974*	0.70	**0.39**	0.51	0.35
MPC Varnish Potential	Scale	ASTM D7843(m)*	>15	**41**	55	22

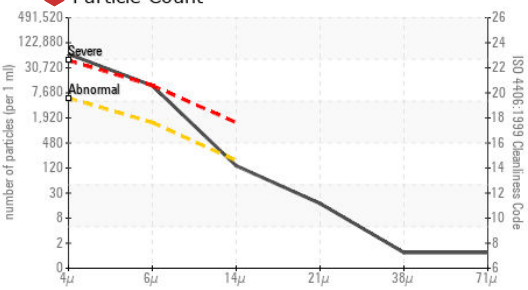
Particle Count

FLUID CLEANLINESS		method	limit/base	current	history1	history2
Particles >4µm		ASTM D7647	>5000	**56945**	40764	3671
Particles >6µm		ASTM D7647	>1300	**9942**	6230	599
Particles >14µm		ASTM D7647	>160	**120**	32	26
Particles >21µm		ASTM D7647	>40	**15**	4	4
Particles >38µm		ASTM D7647	>10	**1**	0	1
Particles >71µm		ASTM D7647	>3	**1**	0	0
Oil Cleanliness		ISO 4406 (c)	>19/17/14	**23/20/14**	23/20/12	19/16/12
