OIL ANALYSIS REPORT

Area
GFL207
Machine Id
4605
Component
Diesel Engine
Fluid
PETRO CANADA DURON SHP 15W40 (36 LTR)

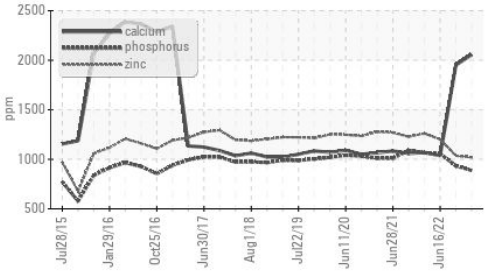
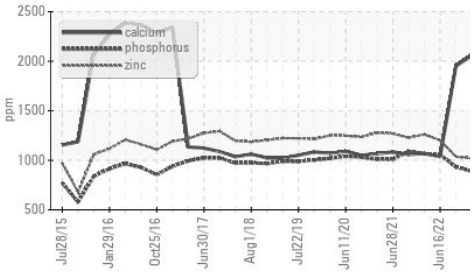
Additives

Fluid Condition
Additive levels indicate the addition of a different brand, or type of oil. The condition of the oil is acceptable for the time in service.

Recommendation
Confirm the source of the lubricant being utilized for top-up/fill. Resample at the next service interval to monitor.

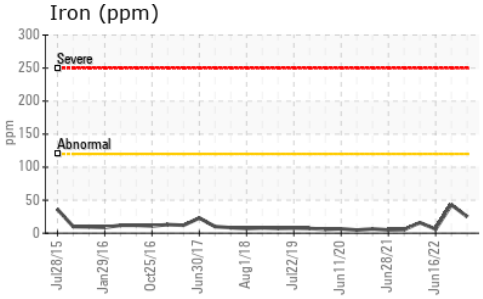
Iron (ppm)

Wear
All component wear rates are normal.

WEAR METALS		method	limit/base	current	history1	history2
Iron	ppm	ASTM D5185(m)	>120	**25**	43	6
Chromium	ppm	ASTM D5185(m)	>20	**<1**	<1	<1
Nickel	ppm	ASTM D5185(m)	>5	**<1**	<1	<1
Titanium	ppm	ASTM D5185(m)	>2	**0**	<1	0
Silver	ppm	ASTM D5185(m)	>2	**0**	0	0
Aluminum	ppm	ASTM D5185(m)	>20	**6**	9	3
Lead	ppm	ASTM D5185(m)	>40	**<1**	4	<1
Copper	ppm	ASTM D5185(m)	>330	**3**	4	1
Tin	ppm	ASTM D5185(m)	>15	**0**	<1	<1
Antimony	ppm	ASTM D5185(m)		**0**	0	0
Vanadium	ppm	ASTM D5185(m)		**0**	0	0
Beryllium	ppm	ASTM D5185(m)		**0**	0	0
Cadmium	ppm	ASTM D5185(m)		**0**	0	0

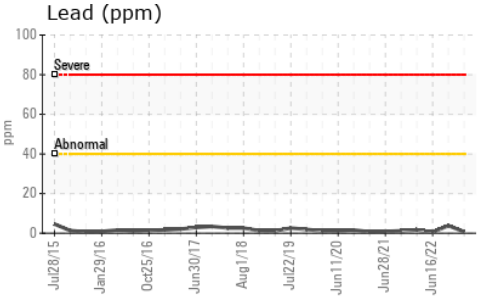
Lead (ppm)

Contamination
Elevated aluminum (Al) and/or lead (Pb) and potassium (K) levels in your metals analysis are likely a result of solder flux release into the lubricant and is common on new equipment/components. There is no indication of any contamination in the oil.

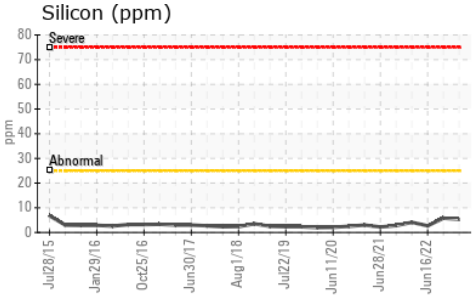
Silicon (ppm)

CONTAMINANTS		method	limit/base	current	history1	history2
Silicon	ppm	ASTM D5185(m)	>25	**5**	6	3
Sodium	ppm	ASTM D5185(m)		**5**	7	2
Potassium	ppm	ASTM D5185(m)	>20	**14**	19	4

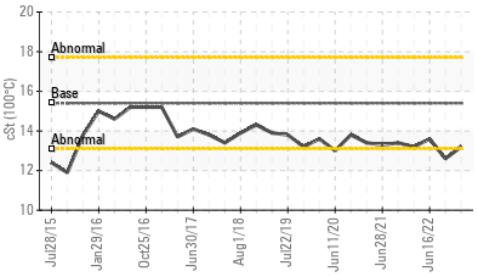
Viscosity @ 100°C

FLUID PROPERTIES		method	limit/base	current	history1	history2
Visc @ 100°C	cSt	ASTM D7279(m)	15.4	**13.2**	12.6	13.6

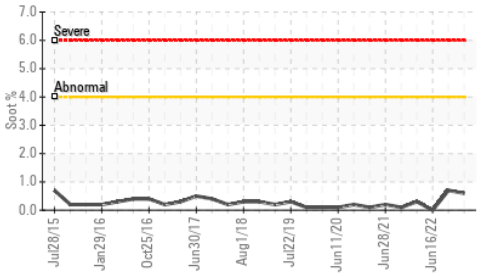
INFRA-RED		method	limit/base	current	history1	history2
Soot %	%	ASTM D7844*	>4	**0.6**	0.7	0
Nitration	Abs/cm	ASTM D7624*	>20	**11.6**	14.6	7.6
Sulfation	Abs/.1mm	ASTM D7415*	>30	**26.6**	33.6	21.0
