Customer Id: TERHAM
Sample No.: PC0081068
Lab Number: 02614505
Test Package: IND 2

OIL ANALYSIS REPORT

Area
[450255637]
Machine Id
PB-04002-HA HOISTING PUMP MID CRANE
Component
Hydraulic System
Fluid
{not provided} (--- GAL)

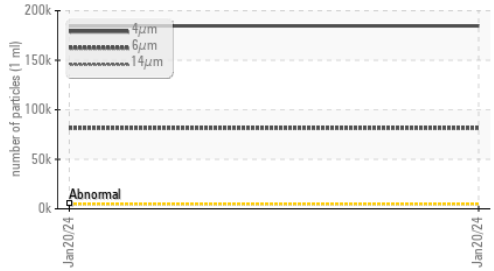
Particle Trend

There is a high amount of particulates (2 to 100 microns in size) present in the oil. There is a moderate concentration of water present in the oil.

FLUID CLEANLINESS		method	limit/base	current	history1	history2
Particles >4µm		ASTM D7647	>5000	⬢ **184686**	---	---
Particles >6µm		ASTM D7647	>1300	⬢ **81511**	---	---
Particles >14µm		ASTM D7647	>160	⬢ **5074**	---	---
Particles >21µm		ASTM D7647	>40	⬢ **820**	---	---
Particles >38µm		ASTM D7647	>10	**13**	---	---
Particles >71µm		ASTM D7647	>3	**1**	---	---
Oil Cleanliness		ISO 4406 (c)	>19/17/14	⬢ **25/24/20**	---	---

Check Dirt Access	---	---	?	We advise that you check all areas where contaminants can enter the system.
Check Seals	---	---	?	Check seals and/or filters for points of contaminant entry.
Filter Fluid	---	---	?	We advise that you perform a filter service, and use off-line filtration to improve the cleanliness of the system fluid.

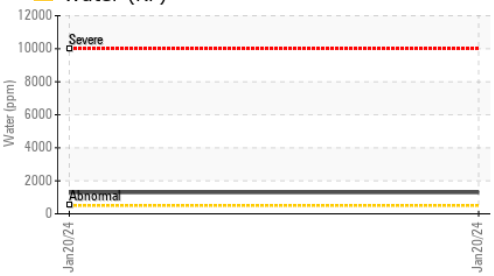
Water (KF)

CONTAMINANTS		method	limit/base	current	history1	history2
Silicon	ppm	ASTM D5185(m)	>15	**2**	---	---
Sodium	ppm	ASTM D5185(m)		**8**	---	---
Potassium	ppm	ASTM D5185(m)	>20	**1**	---	---
Water	%	ASTM D6304*	>0.05	▲ **0.129**	---	---
ppm Water	ppm	ASTM D6304*	>500	▲ **1294**	---	---

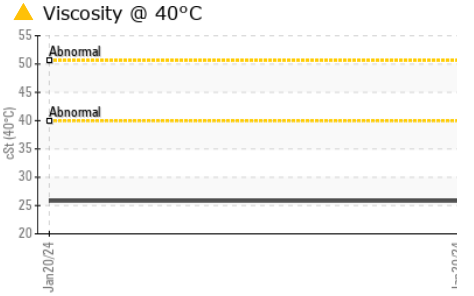
Viscosity @ 40°C

Viscosity of sample indicates oil is within ATF range, advise investigate. The AN level is acceptable for this fluid. The oil is still serviceable provided that the contaminant(s) can be reduced to acceptable levels.

FLUID PROPERTIES		method	limit/base	current	history1	history2
Visc @ 40°C	cSt	ASTM D7279(m)		▲ **25.8**	---	---
Visc @ 100°C	cSt	ASTM D7279(m)		▲ **5.4**	---	---
Viscosity Index (VI)	Scale	ASTM D2270*		**150**	---	---

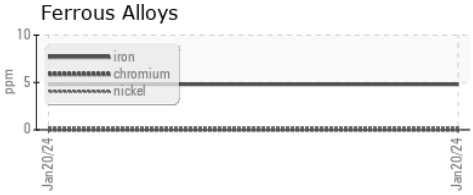
Ferrous Alloys

All component wear rates are normal.
