OIL ANALYSIS REPORT

Machine Id
228003
Component
Diesel Engine
Fluid
DIESEL ENGINE OIL SAE 15W40 (24 LTR)

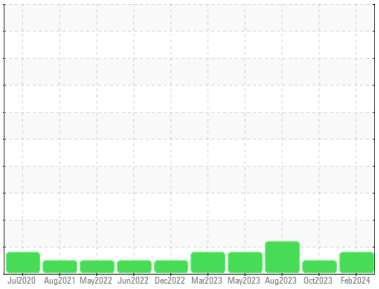
Sample Rating Trend

Contamination
Light fuel dilution occurring. No other contaminants were detected in the oil.

Recommendation
No corrective action is recommended at this time. Resample at the next service interval to monitor.

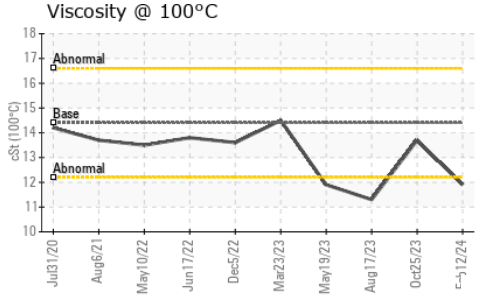
Viscosity @ 100°C

FLUID PROPERTIES		method	limit/base	current	history1	history2
Visc @ 100°C	cSt	ASTM D7279(m)	14.4	**11.9**	13.7	▲ 11.3

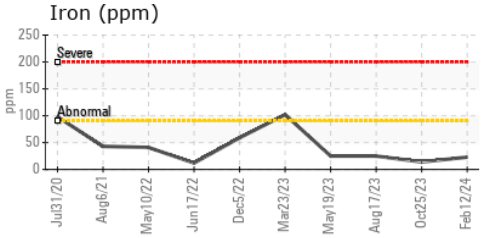
Iron (ppm)

Wear
All component wear rates are normal.
