Customer Id: TERHAM
Sample No.: PC0080294
Lab Number: 02619452
Test Package: AOM 2

OIL ANALYSIS REPORT

Area
[WO 450327061]
Machine Id
Gearbox Fire Water Pump B (S/N Sample Tag CG-71001B)
Component
Gearbox
Fluid
PETRO CANADA PREMIUM R&O 220 (--- LTR)

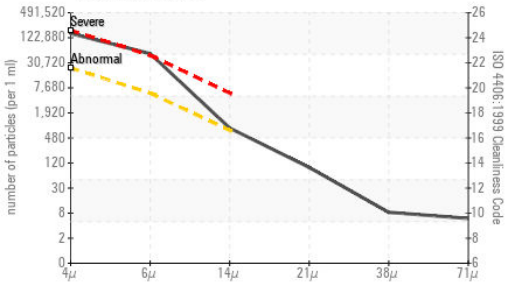
Particle Count

There is a high amount of silt (particulates < 14 microns in size) present in the oil. MPC (Membrane Patch Colorimetry) test indicates a moderate concentration of varnish present.

FLUID CLEANLINESS		method	limit/base	current	history1	history2
Particles >4µm		ASTM D7647	>20000	▲ **134235**	---	---
Particles >6µm		ASTM D7647	>5000	▲ **44139**	---	---
Particles >14µm		ASTM D7647	>640	● **729**	---	---
Particles >21µm		ASTM D7647	>160	**83**	---	---
Particles >38µm		ASTM D7647	>40	**7**	---	---
Particles >71µm		ASTM D7647	>10	**5**	---	---
Oil Cleanliness		ISO 4406 (c)	>21/19/16	▲ **24/23/17**	---	---

Check seals and/or filters for points of contaminant entry. The air breather requires service. If unrated, we recommend that you replace with a suitable micron rated and/or desiccant air breather. If rated, we recommend that you service/replace the breather. We recommend you service the filters on this component. We recommend that you use electrostatic filtration to remove insolubles from the oil and to reduce the levels of varnish in the system. Alternatively draining a percentage of the oil and topping up with fresh oil (sweetening the oil) may provide a reduction in the varnish potential level. Resample in 30-45 days to monitor this situation. NOTE: Please provide information regarding reservoir capacity, filter type and micron rating with next sample. Please submit a sample of the new (unused) oil to establish a baseline.

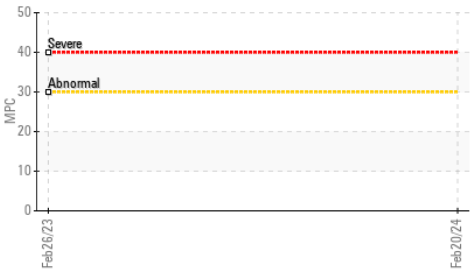
FLUID DEGRADATION		method	limit/base	current	history1	history2
Oxidation	Abs/.1mm	ASTM D7414*		**3.0**	---	---
Acid Number (AN)	mg KOH/g	ASTM D974*	0.20	**0.15**	0.18	---
MPC Varnish Potential	Scale	ASTM D7843(m)*	>15	▲ **45**	---	---

Action	Status	Date	Done By	Description
Change Filter	---	---	?	We recommend you service the filters on this component.
Resample	---	---	?	Resample in 30-45 days to monitor this situation. Please submit a sample of the new (unused) oil to establish a baseline.
Information Required	---	---	?	NOTE: Please provide information regarding reservoir capacity, filter type and micron rating with next sample.
Check Breathers	---	---	?	The air breather requires service. If unrated, we recommend that you replace with a suitable micron rated and/or desiccant air breather. If rated, we recommend that you service/replace the breather.
Check Seals	---	---	?	Check seals and/or filters for points of contaminant entry.
Filter Fluid	---	---	?	We recommend that you use electrostatic filtration to remove insolubles from the oil and to reduce the levels of varnish in the system. Alternatively draining a percentage of the oil and topping up with fresh oil (sweetening the oil) may provide a reduction in the varnish potential level.

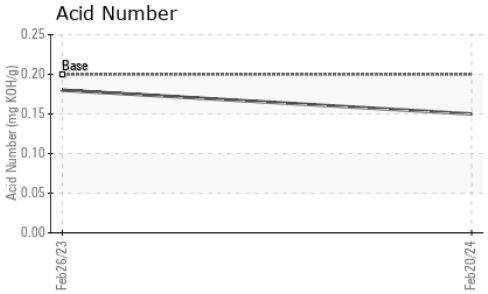
Acid Number

The AN level is acceptable for this fluid. The oil is still serviceable provided that the contaminant(s) can be reduced to acceptable levels.

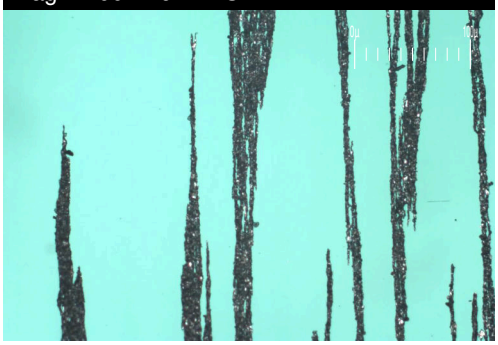
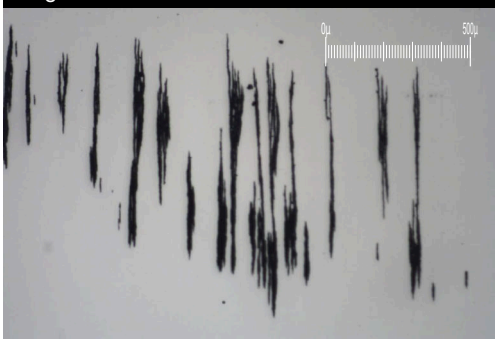
All component wear rates are normal. The ferrography results are normal indicating no abnormal wear in the system.
