OIL ANALYSIS REPORT

Machine Id
711026
Component
Hydraulic System
Fluid
PETRO CANADA HYDREX AW 32 (--- GAL)

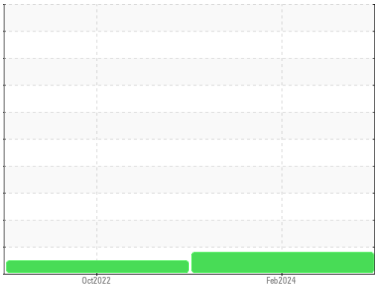
Sample Rating Trend

Il y a une quantité modérée de particules (de 4 à 14 microns) dans l'huile.

l'huile peut encore servir si la contamination peut être réduite à un niveau acceptable.

FLUID CLEANLINESS		method	limit/base	current	history1	history2
Particles >4µm		ASTM D7647	>5000	▲ **20269**	1672	---
Particles >6µm		ASTM D7647	>1300	**628**	397	---
Particles >14µm		ASTM D7647	>160	**36**	21	---
Particles >21µm		ASTM D7647	>40	**12**	5	---
Particles >38µm		ASTM D7647	>10	**2**	0	---
Particles >71µm		ASTM D7647	>3	**1**	0	---
Oil Cleanliness		ISO 4406 (c)	>19/17/14	▲ **22/16/12**	18/16/12	---

Nous avons pris note que le filtre a été remplacé au moment de l'échantillonnage. Nous vous recommandons d'échantillonner de nouveau dès que possible afin de contrôler la situation.
