OIL ANALYSIS REPORT

Machine Id
414019
Component
Diesel Engine
Fluid
DIESEL ENGINE OIL SAE 15W40 (--- LTR)

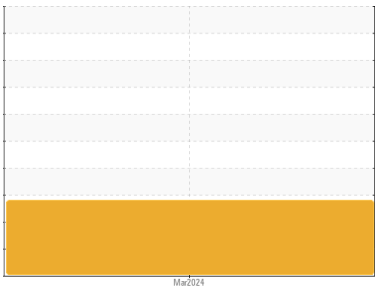
Sample Rating Trend

DIRT

Nickel ppm levels are abnormal. Exhaust valve wear is indicated. We have assumed that this component is not breaking in (age of component not reported).

Fuel content negligible. Elevated aluminum (Al) and/or lead (Pb) and potassium (K) levels in your metals analysis are likely a result of solder flux release into the lubricant and is common on new equipment/components. There is a moderate concentration of dirt present in the oil. High amount of ingressed dirt has caused abrasive wear to the component.

Viscosity of sample indicates oil is within SAE 30 range, advise investigate. The oil is no longer serviceable as a result of the abnormal and/or severe wear.

We advise that you check the air filter, air induction system, and any areas where dirt may enter the component. We recommend that you drain the oil from the component if this has not already been done. We recommend you service the filters on this component. We recommend an early resample to monitor this condition.
