OIL ANALYSIS REPORT

Machine Id
Or1984
Component
Hydraulic System
Fluid
PETRO CANADA HYDREX AW 46 (--- LTR)

Laboratory : WearCheck - C8-1175 Appleby Line, Burlington, ON L7L 5H9
Sample No. : GFL0113298
Lab Number : 02623756
Unique Number : 5748875
Test Package : MOB 1 (Additional Tests: PrtCount)

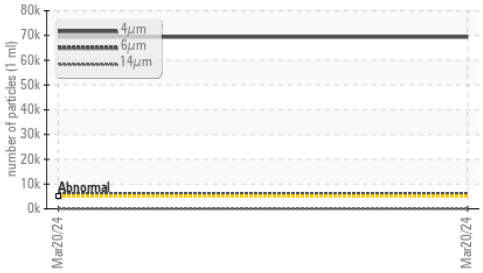
Particle Trend

Contamination
There is a high amount of silt (particulates < 14 microns in size) present in the oil.

FLUID CLEANLINESS		method	limit/base	current	history1	history2
Particles >4µm		ASTM D7647	>5000	**69385**	---	---
Particles >6µm		ASTM D7647	>1300	**5743**	---	---
Particles >14µm		ASTM D7647	>160	**13**	---	---
Particles >21µm		ASTM D7647	>40	**2**	---	---
Particles >38µm		ASTM D7647	>10	**1**	---	---
Particles >71µm		ASTM D7647	>3	**1**	---	---
Oil Cleanliness		ISO 4406 (c)	>19/17/14	**23/20/11**	---	---

Recommendation
Check seals and/or filters for points of contaminant entry. The air breather requires service. If unrated, we recommend that you replace with a suitable micron rated and/or desiccant air breather. If rated, we recommend that you service/replace the breather. We recommend you service the filters on this component. Confirm the source of the lubricant being utilized for top-up/fill. Resample in 30-45 days to monitor this situation.

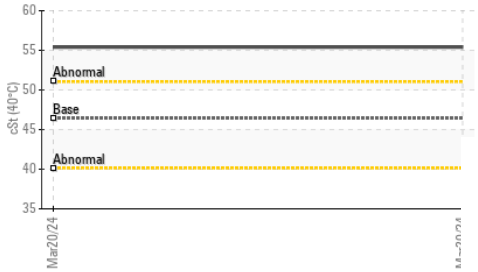
Viscosity @ 40°C

Fluid Condition
The oil viscosity is higher than normal. This plus the additive levels indicates that this is not the same brand, or type of oil as reported. The oil is still serviceable provided that the contaminant(s) can be reduced to acceptable levels.

FLUID PROPERTIES		method	limit/base	current	history1	history2
Visc @ 40°C	cSt	ASTM D7279(m)	46.4	▲ **55.4**	---	---
