Area
Gas Compression [450296476]
Machine Id
Compressor (MP)- Lubrication System (S/N Sample Tag XX-23002-S1)
Component
Lube System
Fluid
PETRO CANADA TURBOFLO XL32 (10350 LTR)

Customer Id: TERHAM
Sample No.: PC0081650
Lab Number: 02631142
Test Package: MAR 2

OIL ANALYSIS REPORT

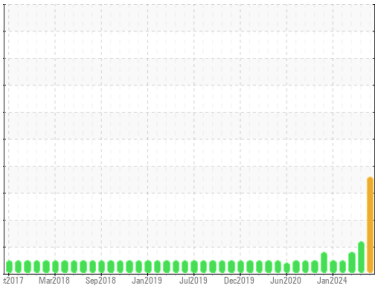
Sample Rating Trend

Sample Status				SEVERE	ABNORMAL	ATTENTION
Particles >6µm		ASTM D7647	>2500	**20907**	12630	2906
Particles >14µm		ASTM D7647	>320	**695**	521	196
Oil Cleanliness		ISO 4406 (c)	>--/18/15	**24/22/17**	23/21/16	21/19/15

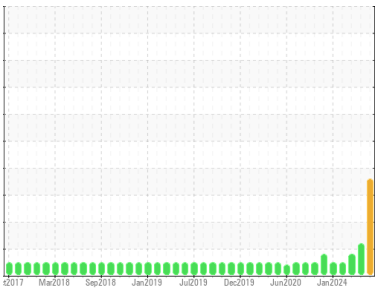
Sample Rating Trend

There is a high amount of silt (particulates < 14 microns in size) present in the oil. The system cleanliness code is much higher than the acceptable limit for the target ISO 4406 cleanliness code.

Check seals and/or filters for points of contaminant entry. The air breather requires service. If unrated, we recommend that you replace with a suitable micron rated and/or desiccant air breather. If rated, we recommend that you service/replace the breather. We recommend you service the filters on this component. Resample in 30-45 days to monitor this situation. Please contact your representative for information regarding the proper sampling kits for your service. NOTE: We recommend using MAR 3 test kits, this testkit includes Analytical Ferrography which provides a detailed morphological analysis of wear particles present in the fluid.

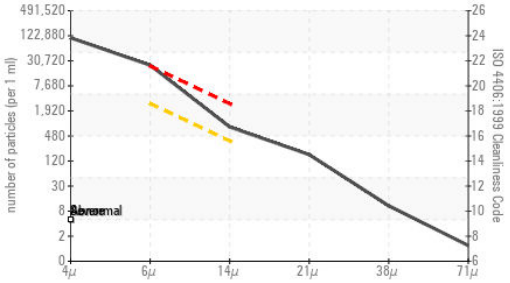
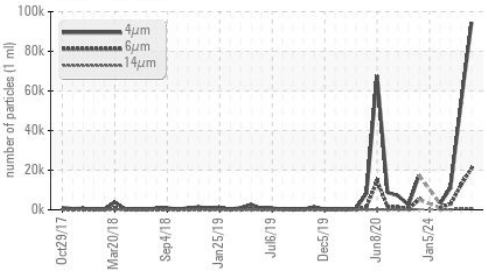
Particle Count

FLUID CLEANLINESS	method	limit/base	current	history1	history2
Particles >4µm	ASTM D7647		**94594**	53985	11069
Particles >6µm	ASTM D7647	>2500	▲ **20907**	▲ 12630	● 2906
Particles >14µm	ASTM D7647	>320	▲ **695**	● 521	196
Particles >21µm	ASTM D7647	>80	● **151**	103	57
Particles >38µm	ASTM D7647	>20	**9**	6	4
Particles >71µm	ASTM D7647	>4	**1**	1	0
Oil Cleanliness	ISO 4406 (c)	>--/18/15	▲ **24/22/17**	▲ 23/21/16	● 21/19/15

Check seals and/or filters for points of contaminant entry. The air breather requires service. If unrated, we recommend that you replace with a suitable micron rated and/or desiccant air breather. If rated, we recommend that you service/replace the breather. We recommend you service the filters on this component. Resample in 30-45 days to monitor this situation. Please contact your representative for information regarding the proper sampling kits for your service. NOTE: We recommend using MAR 3 test kits, this testkit includes Analytical Ferrography which provides a detailed morphological analysis of wear particles present in the fluid.

Action	Status	Date	Done By	Description
Change Filter	---	---	?	We recommend you service the filters on this component.
Resample	---	---	?	Resample in 30-45 days to monitor this situation.
Contact Required	---	---	?	Please contact your representative for information regarding the proper sampling kits for your service.
Alert	---	---	?	NOTE: We recommend using MAR 3 test kits,
Check Breathers	---	---	?	The air breather requires service. If unrated, we recommend that you replace with a suitable micron rated and/or desiccant air breather. If rated, we recommend that you service/replace the breather.
Check Seals	---	---	?	Check seals and/or filters for points of contaminant entry.

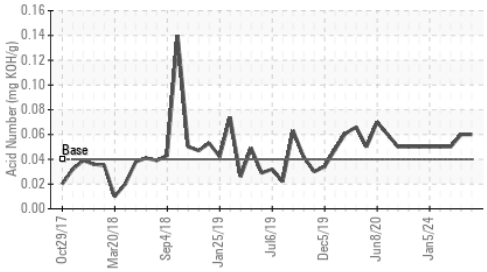
The AN level is acceptable for this fluid. The oil is still serviceable provided that the contaminant(s) can be reduced to acceptable levels.

FLUID DEGRADATION		method	limit/base	current	history1	history2
Acid Number (AN)	mg KOH/g	ASTM D974*	0.04	**0.06**	0.06	0.05
