Area
Gas Compression [450296470]
Machine Id
Compressor (HP1) - Lubrication System (S/N Sample Tag XX-23003-S1)
Component
Lube System
Fluid
PETRO CANADA TURBOFLO XL32 (10350 LTR)

Customer Id: TERHAM
Sample No.: PC0081646
Lab Number: 02631145
Test Package: MAR 2

OIL ANALYSIS REPORT

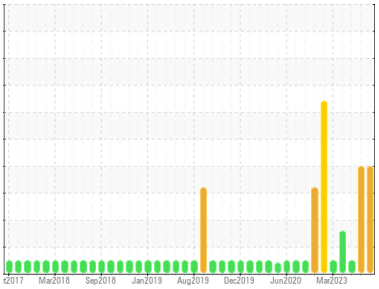
Sample Rating Trend

Sample Status				SEVERE	SEVERE	NORMAL
Particles >6µm		ASTM D7647	>2500	▲ **21924**	▲ 34682	350
Particles >14µm		ASTM D7647	>320	▲ **1402**	▲ 2420	49
Particles >21µm		ASTM D7647	>80	▲ **370**	▲ 567	18
Oil Cleanliness		ISO 4406 (c)	>--/18/15	▲ **24/22/18**	▲ 24/22/18	17/16/13

We advise that you check all areas where contaminants can enter the system. We advise that you perform a filter service, and use off-line filtration to improve the cleanliness of the system fluid. The air breather requires service. If unrated, we recommend that you replace with a suitable micron rated and/or desiccant air breather. If rated, we recommend that you service/replace the breather. Confirm the source of the lubricant being utilized for top-up/fill. Resample in 30-45 days to monitor this situation.

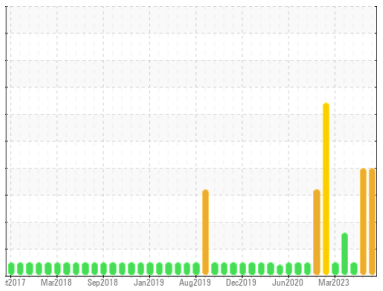
Sample Rating Trend

Contamination
There is a high amount of particulates (2 to 100 microns in size) present in the oil. The system cleanliness code is much higher than the acceptable limit for the target ISO 4406 cleanliness code.

Fluid Condition
Additive levels indicate the addition of a different brand, or type of oil. The AN level is acceptable for this fluid. The oil is still serviceable provided that the contaminant(s) can be reduced to acceptable levels.

Recommendation
We advise that you check all areas where contaminants can enter the system. We advise that you perform a filter service, and use off-line filtration to improve the cleanliness of the system fluid. The air breather requires service. If unrated, we recommend that you replace with a suitable micron rated and/or desiccant air breather. If rated, we recommend that you service/replace the breather. Confirm the source of the lubricant being utilized for top-up/fill. Resample in 30-45 days to monitor this situation.

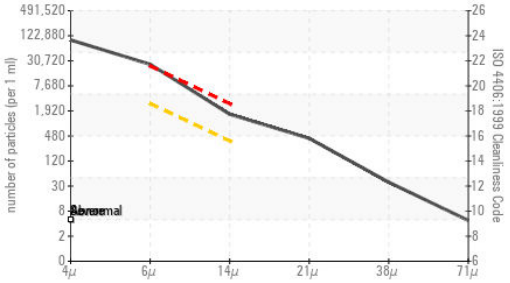
Particle Count

FLUID CLEANLINESS	method	limit/base	current	history1	history2
Particles >4µm	ASTM D7647		**83961**	97668	1150
Particles >6µm	ASTM D7647	>2500	▲ **21924**	▲ 34682	350
Particles >14µm	ASTM D7647	>320	▲ **1402**	▲ 2420	49
Particles >21µm	ASTM D7647	>80	▲ **370**	▲ 567	18
Particles >38µm	ASTM D7647	>20	● **33**	● 36	3
Particles >71µm	ASTM D7647	>4	**4**	1	2
Oil Cleanliness	ISO 4406 (c)	>--/18/15	▲ **24/22/18**	▲ 24/22/18	17/16/13

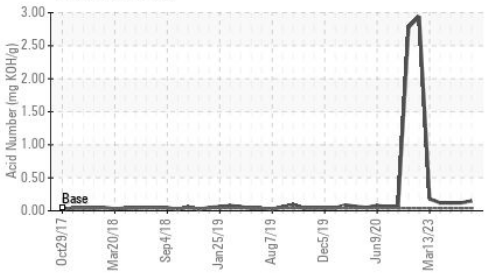
FLUID DEGRADATION		method	limit/base	current	history1	history2
Acid Number (AN)	mg KOH/g	ASTM D974*	0.04	**0.15**	0.12	0.12
