PROBLEM SUMMARY

Area
[450296514]
Machine Id
EG-80201 EQ MPG
Component
Port Turbine
Fluid
TURBINE OIL ISO 32 (--- GAL)

OIL ANALYSIS REPORT

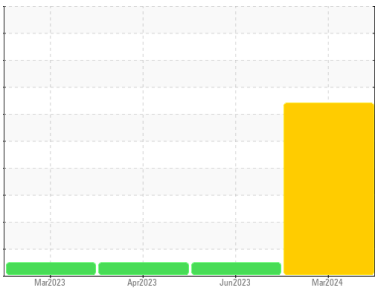
Sample Rating Trend

Sample Status				SEVERE	NORMAL	NORMAL
Particles >4µm		ASTM D7647	>2500	▲ **46712**	223	383
Particles >6µm		ASTM D7647	>640	▲ **14966**	57	76
Particles >14µm		ASTM D7647	>80	▲ **654**	6	5
Particles >21µm		ASTM D7647	>20	▲ **115**	2	2
Oil Cleanliness		ISO 4406 (c)	>18/16/13	▲ **23/21/17**	15/13/10	16/13/10

Action	Status	Date	Done By	Description
Change Filter	---	---	?	We advise that you perform a filter service, and use off-line filtration to improve the cleanliness of the system fluid.
Resample	---	---	?	Resample in 30-45 days to monitor this situation.
Alert	---	---	?	Little or no information is provided as to the component and lubricant being tested. Recommendations are therefore generic in nature and may not apply to the current application. Please forward information as to equipment type, reservoir capacity, lubricant type and any pertinent information to allow for a more accurate assessment.
Information Required	---	---	?	Please specify the brand, type, and viscosity of the oil on your next sample. NOTE: Please provide information regarding reservoir capacity, filter type and micron rating with next sample.
Check Breathers	---	---	?	The air breather requires service. If unrated, we recommend that you replace with a suitable micron rated and/or desiccant air breather. If rated, we recommend that you service/replace the breather.

Check Dirt Access	---	---	?	We advise that you check all areas where contaminants can enter the system.
Filter Fluid	---	---	?	We advise that you perform a filter service, and use off-line filtration to improve the cleanliness of the system fluid.

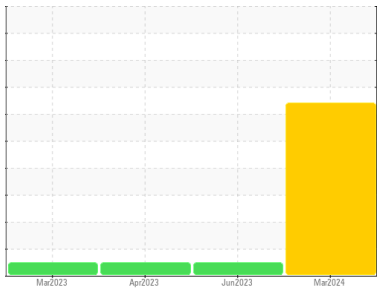
Sample Rating Trend

Contamination
There is a high amount of particulates (2 to 100 microns in size) present in the oil. The water content is negligible.

Fluid Condition
The AN level is acceptable for this fluid. The oil is still serviceable provided that the contaminant(s) can be reduced to acceptable levels.

Recommendation
Little or no information is provided as to the component and lubricant being tested. Recommendations are therefore generic in nature and may not apply to the current application. Please forward information as to equipment type, reservoir capacity, lubricant type and any pertinent information to allow for a more accurate assessment. We advise that you check all areas where contaminants can enter the system. We advise that you perform a filter service, and use off-line filtration to improve the cleanliness of the system fluid. The air breather requires service. If unrated, we recommend that you replace with a suitable micron rated and/or desiccant air breather. If rated, we recommend that you service/replace the breather. Resample in 30-45 days to monitor this situation. NOTE: Please provide information regarding reservoir capacity, filter type and micron rating with next sample. Please specify the brand, type, and viscosity of the oil on your next sample.

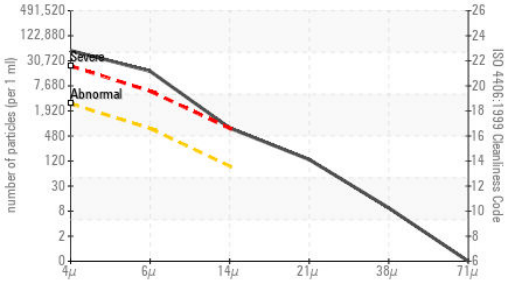
Particle Count

FLUID CLEANLINESS		method	limit/base	current	history1	history2
Particles >4µm		ASTM D7647	>2500	▲ **46712**	223	383
Particles >6µm		ASTM D7647	>640	▲ **14966**	57	76
Particles >14µm		ASTM D7647	>80	▲ **654**	6	5
Particles >21µm		ASTM D7647	>20	▲ **115**	2	2
Particles >38µm		ASTM D7647	>4	● **8**	0	0
Particles >71µm		ASTM D7647	>3	**0**	0	0
Oil Cleanliness		ISO 4406 (c)	>18/16/13	▲ **23/21/17**	15/13/10	16/13/10

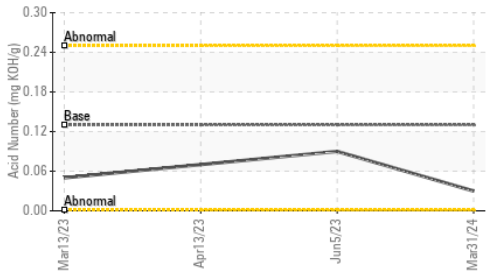
FLUID DEGRADATION		method	limit/base	current	history1	history2
Acid Number (AN)	mg KOH/g	ASTM D974*	0.13	**0.03**	0.09	0.07
