OIL ANALYSIS REPORT

Machine Id
701032
Component
Diesel Engine
Fluid
PETRO CANADA DURON SHP 15W40 (25 LTR)

Laboratory : WearCheck - C8-1175 Appleby Line, Burlington, ON L7L 5H9
Sample No. : GFL0122303
Lab Number : 02640094
Unique Number : 5789256
Test Package : MOB 1 (Additional Tests: Visual)

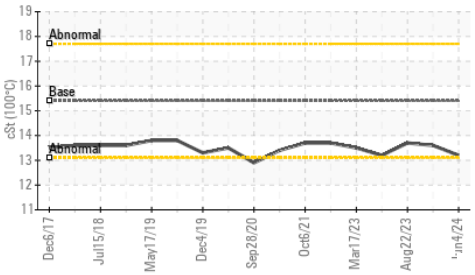
Viscosity @ 100°C

Fluid Condition
The condition of the oil is acceptable for the time in service.

FLUID PROPERTIES		method	limit/base	current	history1	history2
Visc @ 100°C	cSt	ASTM D7279(m)	15.4	**13.2**	13.6	13.7

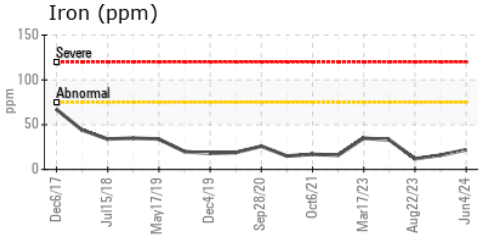
Iron (ppm)

Wear
Metal levels are typical for a new component breaking in.

WEAR METALS		method	limit/base	current	history1	history2
Iron	ppm	ASTM D5185(m)	>75	**22**	16	12
Chromium	ppm	ASTM D5185(m)	>5	**<1**	<1	<1
Nickel	ppm	ASTM D5185(m)	>4	**0**	<1	0
Titanium	ppm	ASTM D5185(m)	>2	**0**	0	0
Silver	ppm	ASTM D5185(m)	>2	**0**	<1	0
Aluminum	ppm	ASTM D5185(m)	>15	**10**	3	2
Lead	ppm	ASTM D5185(m)	>25	**0**	<1	0
Copper	ppm	ASTM D5185(m)	>100	**1**	1	<1
Tin	ppm	ASTM D5185(m)	>4	**0**	0	0
Antimony	ppm	ASTM D5185(m)		**0**	0	0
Vanadium	ppm	ASTM D5185(m)		**0**	0	0
Beryllium	ppm	ASTM D5185(m)		**0**	0	0
Cadmium	ppm	ASTM D5185(m)		**0**	0	0

Recommendation
Resample at the next service interval to monitor.

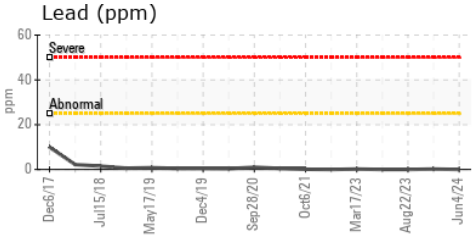
Lead (ppm)

Contamination
Elevated aluminum (Al) and/or lead (Pb) and potassium (K) levels in your metals analysis are likely a result of solder flux release into the lubricant and is common on new equipment/components. There is no indication of any contamination in the oil.

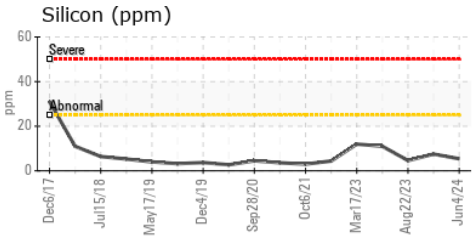
Silicon (ppm)

CONTAMINANTS		method	limit/base	current	history1	history2
Silicon	ppm	ASTM D5185(m)	>25	**5**	8	5
Sodium	ppm	ASTM D5185(m)		**6**	6	5
Potassium	ppm	ASTM D5185(m)	>20	**18**	2	2
