LUBE 360 DIAGNOSTICS

OIL ANALYSIS REPORT

Area
{UNASSIGNED}
Machine Id
Gates Hose crimper (S/N TSI1034J21)
Component
Hydraulic System
Fluid
{not provided} (30 LTR)

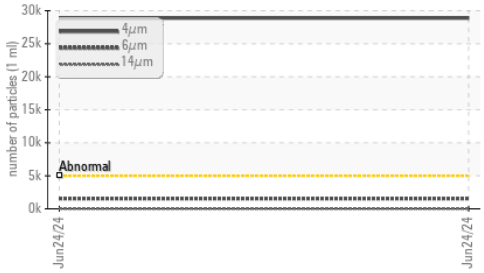
Particle Trend

Contamination
There is a moderate amount of silt (particulates < 14 microns in size) present in the oil.

FLUID CLEANLINESS		method	limit/base	current	history1	history2
Particles >4µm		ASTM D7647	>5000	▲ **28877**	---	---
Particles >6µm		ASTM D7647	>1300	● **1549**	---	---
Particles >14µm		ASTM D7647	>160	**18**	---	---
Particles >21µm		ASTM D7647	>40	**4**	---	---
Particles >38µm		ASTM D7647	>10	**1**	---	---
Particles >71µm		ASTM D7647	>3	**1**	---	---
Oil Cleanliness		ISO 4406 (c)	>19/17/14	▲ **22/18/11**	---	---

Recommendation
We recommend you service the filters on this component. We recommend an early resample to monitor this condition. Please specify the brand, type, and viscosity of the oil on your next sample.
