OIL ANALYSIS REPORT

Area
Aft Machinery Space
Machine Id
Thruster Aft Starboard - Lubrication System (S/N Sample Tag CL-06003-S1)
Component
Lube System
Fluid
PETRO CANADA ENERGOL GR-XP ISO 150 (5000 LTR)

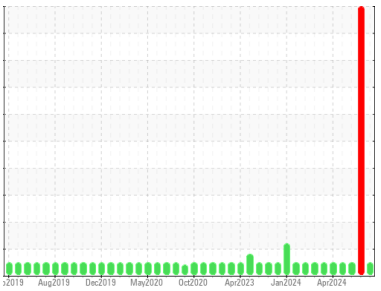
Sample Rating Trend

NORMAL

Wear
Component wear rates appear to be normal (unconfirmed).

Recommendation
Resample at the next service interval to monitor. Please contact your representative for information regarding the proper sampling kits for your service. NOTE: We recommend using IND 3 test kits, this testkit includes Analytical Ferrography which provides a detailed morphological analysis of wear particles present in the fluid.

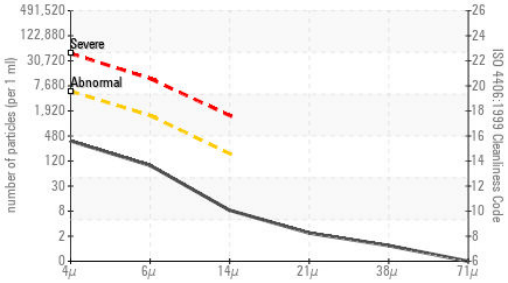
Particle Count

Contamination
The system cleanliness is acceptable for your target ISO 4406 cleanliness code. The system and fluid cleanliness is acceptable.

FLUID CLEANLINESS		method	limit/base	current	history1	history2
Particles >4µm		ASTM D7647	>5000	**321**	▲ 124065	353
Particles >6µm		ASTM D7647	>1300	**83**	▲ 12740	91
Particles >14µm		ASTM D7647	>160	**7**	▲ 376	6
Particles >21µm		ASTM D7647	>40	**2**	▲ 81	1
Particles >38µm		ASTM D7647	>10	**1**	0	0
Particles >71µm		ASTM D7647	>3	**0**	0	0
Oil Cleanliness		ISO 4406 (c)	>19/17/14	**16/14/10**	▲ 24/21/16	16/14/10

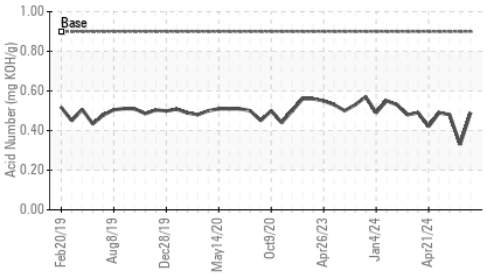
Fluid Condition
The AN level is acceptable for this fluid. The condition of the oil is suitable for further service.

FLUID DEGRADATION		method	limit/base	current	history1	history2
Acid Number (AN)	mg KOH/g	ASTM D974*	0.9	**0.49**	0.33	0.48

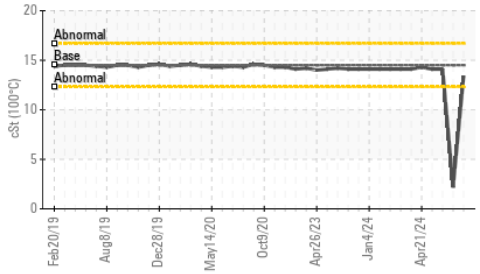
Viscosity @ 100°C

FLUID PROPERTIES		method	limit/base	current	history1	history2
Visc @ 40°C	cSt	ASTM D7279(m)	149	**143**	144	142
Visc @ 100°C	cSt	ASTM D7279(m)	14.5	**13.4**	2.2	14.1
Viscosity Index (VI)	Scale	ASTM D2270*		**86**	---	95

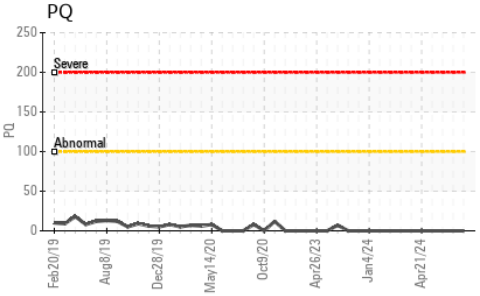
WEAR METALS		method	limit/base	current	history1	history2
PQ		ASTM D8184*		**0**	0	0
Iron	ppm	ASTM D5185(m)	>20	**2**	12	1
Chromium	ppm	ASTM D5185(m)	>10	**0**	1	0
Nickel	ppm	ASTM D5185(m)	>10	**<1**	0	0
Titanium	ppm	ASTM D5185(m)		**0**	0	0
Silver	ppm	ASTM D5185(m)		**0**	0	0
Aluminum	ppm	ASTM D5185(m)	>10	**<1**	0	0
Lead	ppm	ASTM D5185(m)	>20	**0**	0	0
Copper	ppm	ASTM D5185(m)	>20	**<1**	<1	0
Tin	ppm	ASTM D5185(m)	>10	**0**	0	0
Antimony	ppm	ASTM D5185(m)		**0**	0	0
Vanadium	ppm	ASTM D5185(m)		**0**	0	0
Beryllium	ppm	ASTM D5185(m)		**0**	0	0
Cadmium	ppm	ASTM D5185(m)		**0**	0	0
