OIL DIAGNOSTICS

Machine Id
MAX 8 (S/N 6342)
Component
Hydraulic System
Fluid
PETRO CANADA CALFLO AF (25 GAL)

Customer Id: GALGURIL
Sample No.: PCA0067938
Lab Number: 05710963
Test Package: PLANT

OIL ANALYSIS REPORT

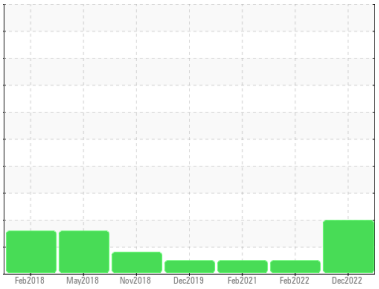
Sample Rating Trend

Sample Status				ATTENTION	NORMAL	NORMAL
Particles >4µm		ASTM D7647	>5000	▲ **6896**	501	2332
Particles >6µm		ASTM D7647	>1300	▲ **2419**	179	649
Particles >14µm		ASTM D7647	>160	▲ **228**	26	71
Particles >21µm		ASTM D7647	>40	▲ **68**	10	23
Oil Cleanliness		ISO 4406 (c)	>19/17/14	▲ **20/18/15**	16/15/12	18/17/13

No corrective action is recommended at this time.
Resample at the next service interval to monitor.

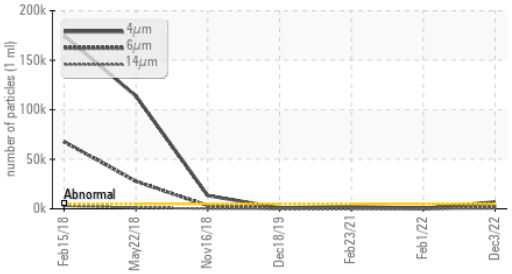
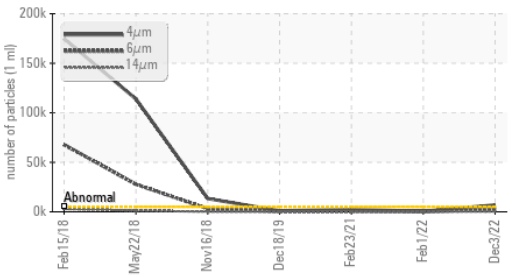
Particle Trend

▲ Contamination
There is a moderate amount of particulates present in the oil.

FLUID CLEANLINESS		method	limit/base	current	history1	history2
Particles >4µm		ASTM D7647	>5000	▲ **6896**	501	2332
Particles >6µm		ASTM D7647	>1300	▲ **2419**	179	649
Particles >14µm		ASTM D7647	>160	▲ **228**	26	71
Particles >21µm		ASTM D7647	>40	▲ **68**	10	23
Particles >38µm		ASTM D7647	>10	**3**	0	0
Particles >71µm		ASTM D7647	>3	**1**	0	0
Oil Cleanliness		ISO 4406 (c)	>19/17/14	▲ **20/18/15**	16/15/12	18/17/13

▲ Recommendation
No corrective action is recommended at this time. Resample at the next service interval to monitor.

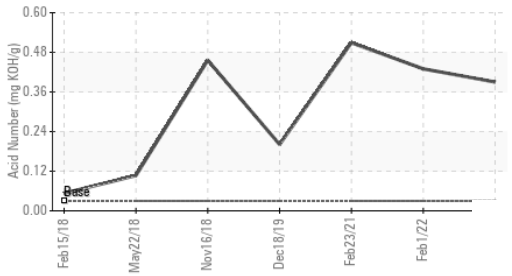
Fluid Condition
The AN level is acceptable for this fluid. The condition of the oil is suitable for further service.

FLUID DEGRADATION		method	limit/base	current	history1	history2
Acid Number (AN)	mg KOH/g	ASTM D8045	0.03	**0.39**	0.43	0.509

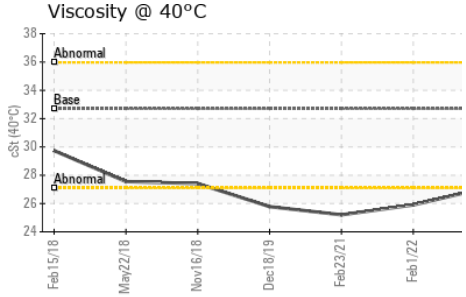
Viscosity @ 40°C

FLUID PROPERTIES		method	limit/base	current	history1	history2
Visc @ 40°C	cSt	ASTM D445	32.7	**27.1**	25.9	25.2
