PROBLEM SUMMARY

Machine Id
427180 - SW4720
Component
Diesel Engine
Fluid
PETRO CANADA DURON SHP 15W40 (--- GAL)

OIL ANALYSIS REPORT

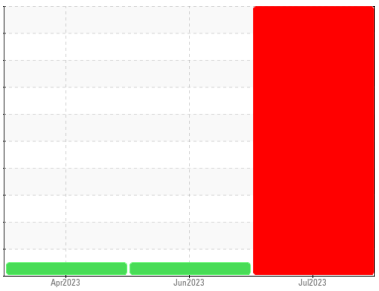
Sample Rating Trend

WEAR

Sample Status				SEVERE	NORMAL	NORMAL
Iron	ppm	ASTM D5185m	>100	**383**	15	14
Nickel	ppm	ASTM D5185m	>4	**9**	<1	0
Aluminum	ppm	ASTM D5185m	>20	**20**	2	0
Silicon	ppm	ASTM D5185m	>25	**77**	7	4

We advise that you check the air filter, air induction system, and any areas where dirt may enter the component. Oil and filter change at the time of sampling has been noted. We recommend an early resample to monitor this condition.

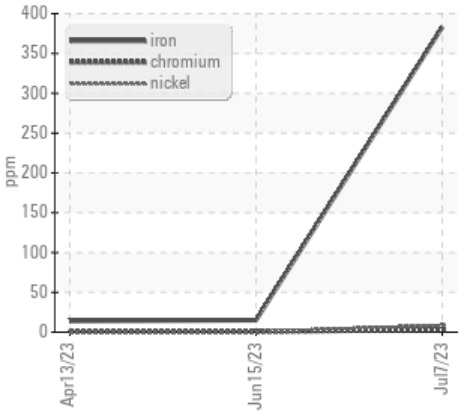
Ferrous Alloys

Wear
Cylinder, crank, or cam shaft wear is indicated. Valve wear is indicated.

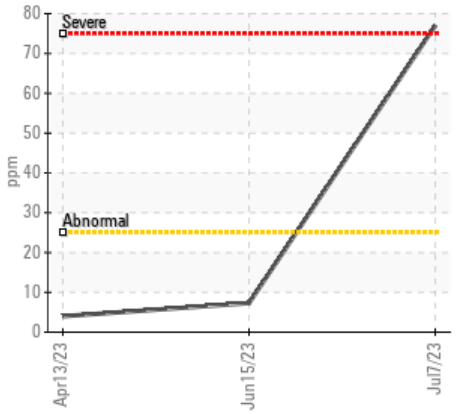
Silicon (ppm)

Contamination
Elemental levels of silicon (Si) and aluminum (Al) indicate alumina-silicate (coarse dirt) ingress.

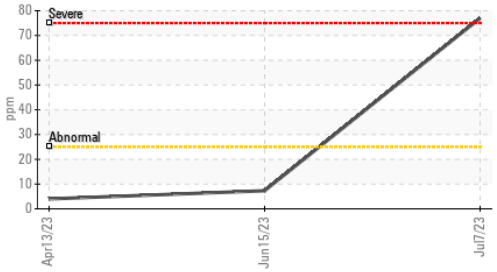
Silicon (ppm)

CONTAMINANTS		method	limit/base	current	history1	history2
Silicon	ppm	ASTM D5185m	>25	**77**	7	4
Sodium	ppm	ASTM D5185m		**4**	<1	1
Potassium	ppm	ASTM D5185m	>20	**7**	5	4
